DOT/FAA/AR-07/35

Summary and Comparison Report on Teardown Evaluation of Cessna 402A and Cessna 402C Airplanes

June 2007

Final Report

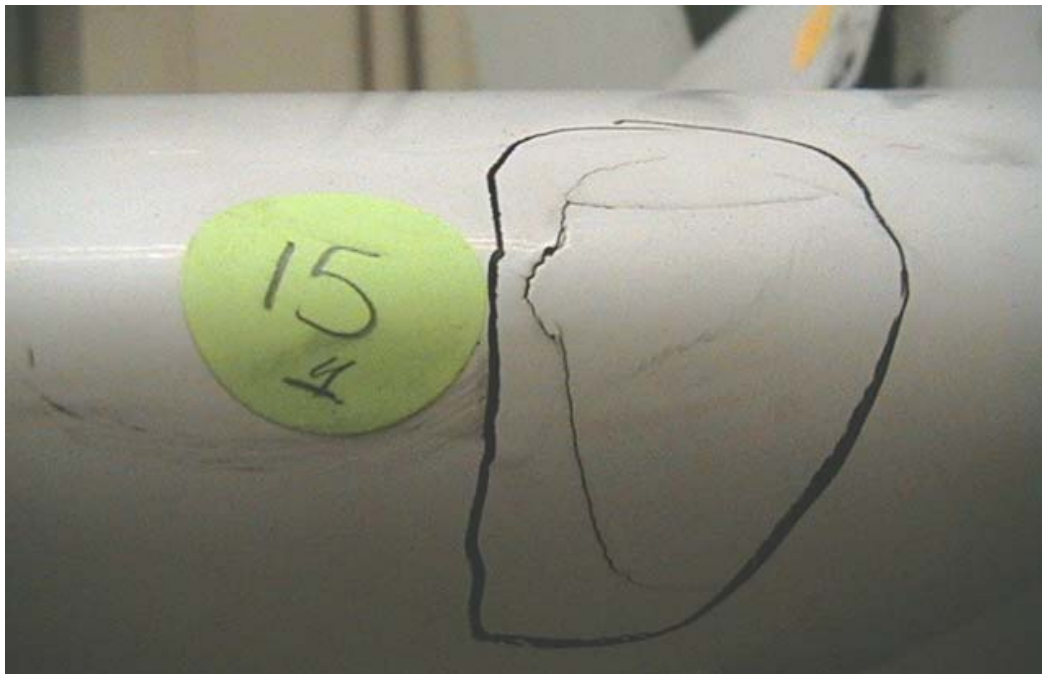
A few defects noted by the inspectors were determined to be more serious in nature. Two 2.5-inch cracks on the leading edge of each horizontal stabilizer were discovered during inspections. One of these cracks is shown in figure 3. The cracks were further investigated and found to be body filler that cracked where the deicing boots were removed. One loose nut was found during inspection of the flaps. The loose nut could possibly be attributed to the initial disassembly of the airplane prior to transportation. Broken gear teeth, shown in figure 4, were observed on the left fuel selector valve.

Figure 3. Leading-Edge Crack on the Cessna 402A Horizontal Stabilizer

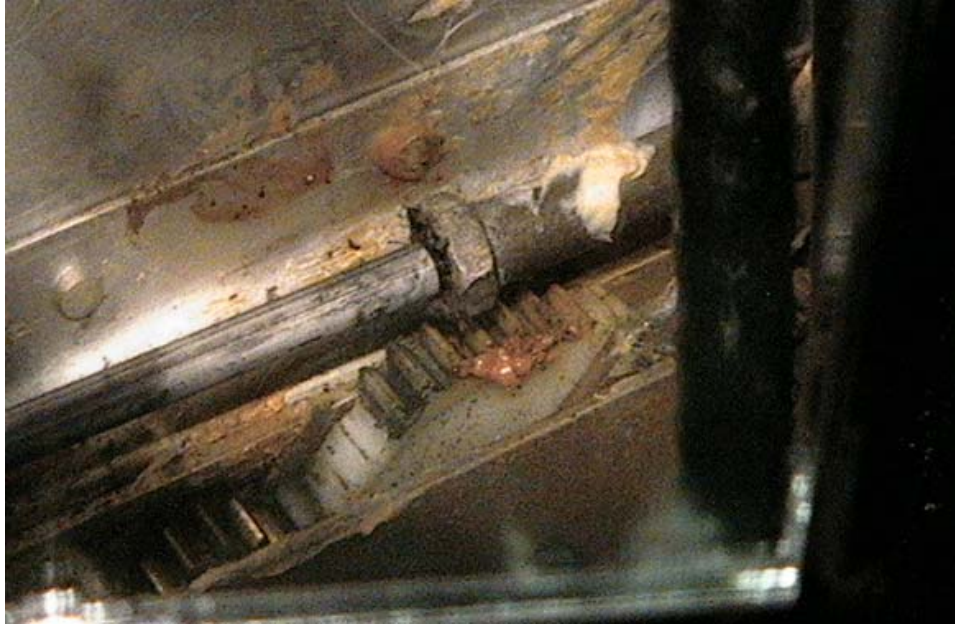
Figure 4. Broken Teeth on the Cessna 402A Left Fuel Selector Valve

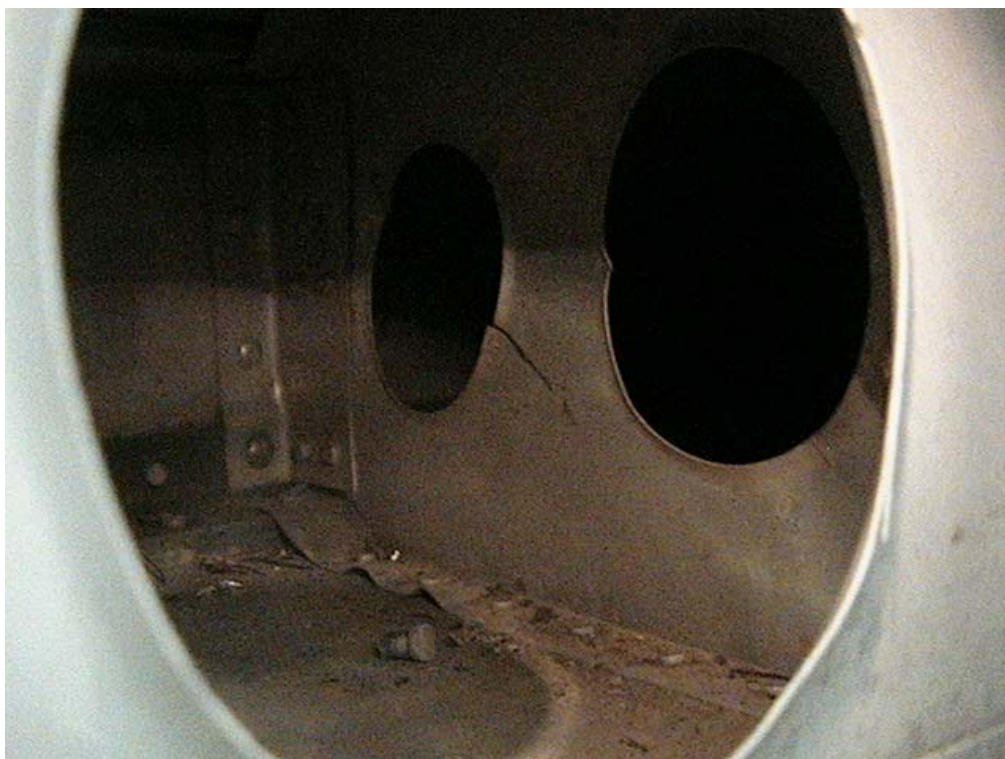
Figure 5 shows a cracked rib in the horizontal stabilizer found during the supplemental visual inspections, while figure 6 shows a skin crack found during the bolthole eddy-current inspection of the lower front spar. The crack in figure 6 measures approximately 1-inch and is common to both fastener holes shown.

Figure 5. Cracked Rib in the Cessna 402A Horizontal Stabilizer

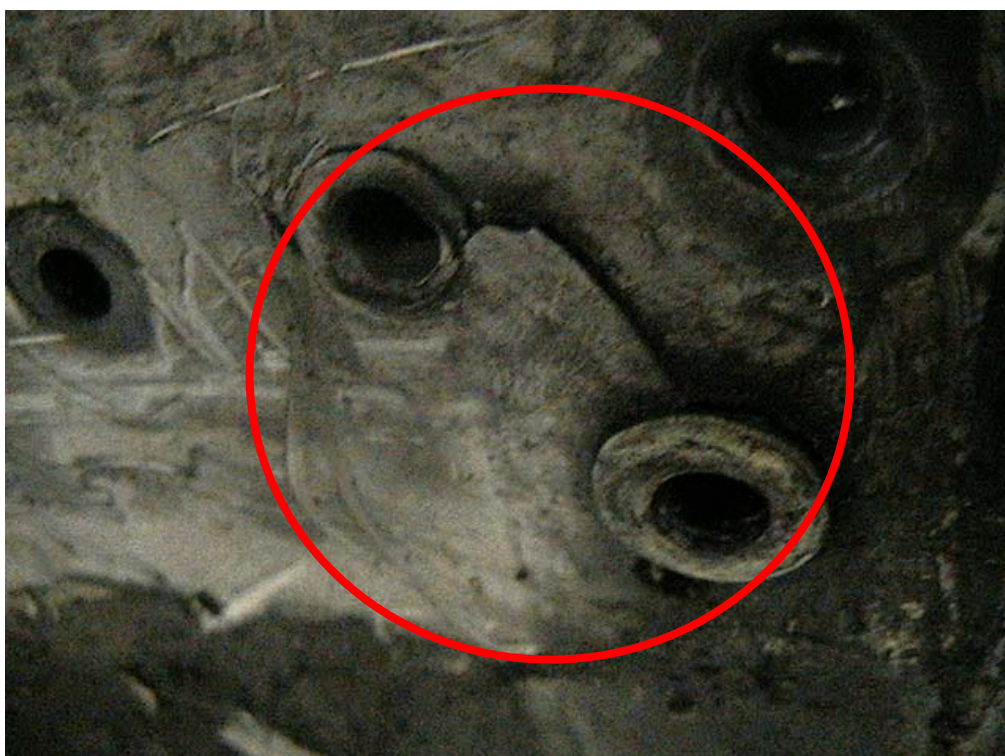
Figure 6. Crack on the Cessna 402A Right Wing Lower Skin

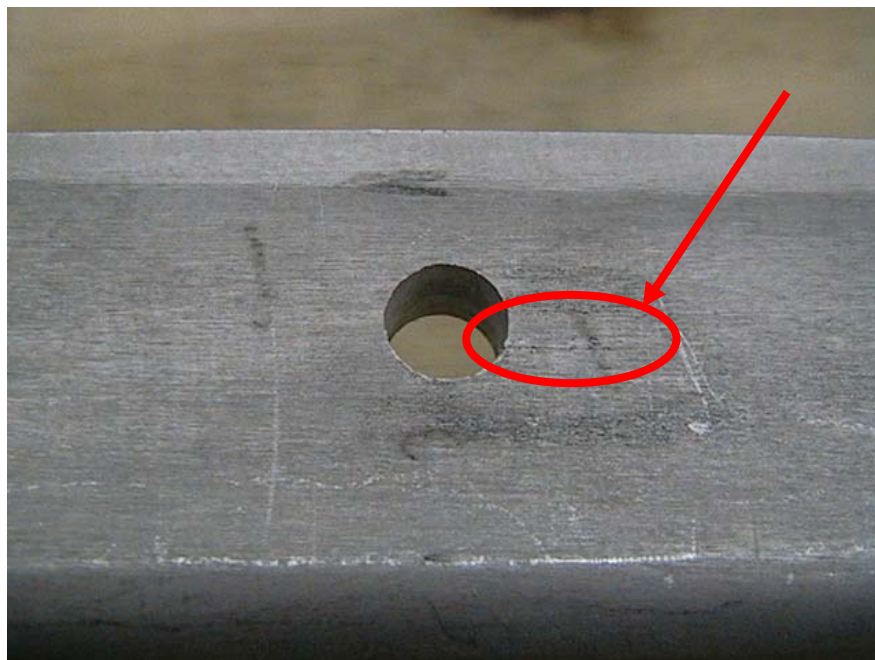
One of the eight stub wing attach fittings was found to have a 0.24-inch crack, as shown in figure 7. This crack was oriented parallel to the load path and found to be caused by stress corrosion. This fitting was the only stub wing attach fitting that had any defects. Two of the right stub wing upper skins had areas of corrosion. These corrosion areas were classified as severe and only occurred on the right wing. Four of the eight front wing attach fittings were found to have corrosion. Three of these fittings were located on the left wing. The left wing front spar lower front root fitting had the most significant corrosion, which was classified as moderate-to-severe and is shown in figure 8. The front spars on both wings had several areas of corrosion, located on the lower cap of the front spars. The left wing exhibited the most corrosion, with an area of moderate corrosion.

Figure 7. Stress Corrosion Crack on the Cessna 402A Stub Wing Attach Fitting

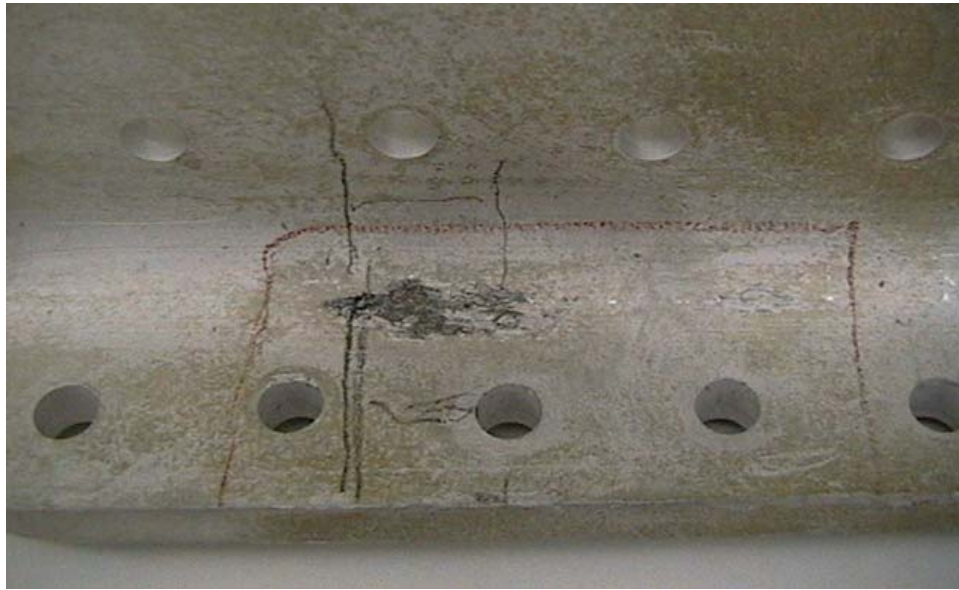
Figure 8. Moderate-Severe Corrosion on the Cessna 402A Left Wing Lower Front Fitting

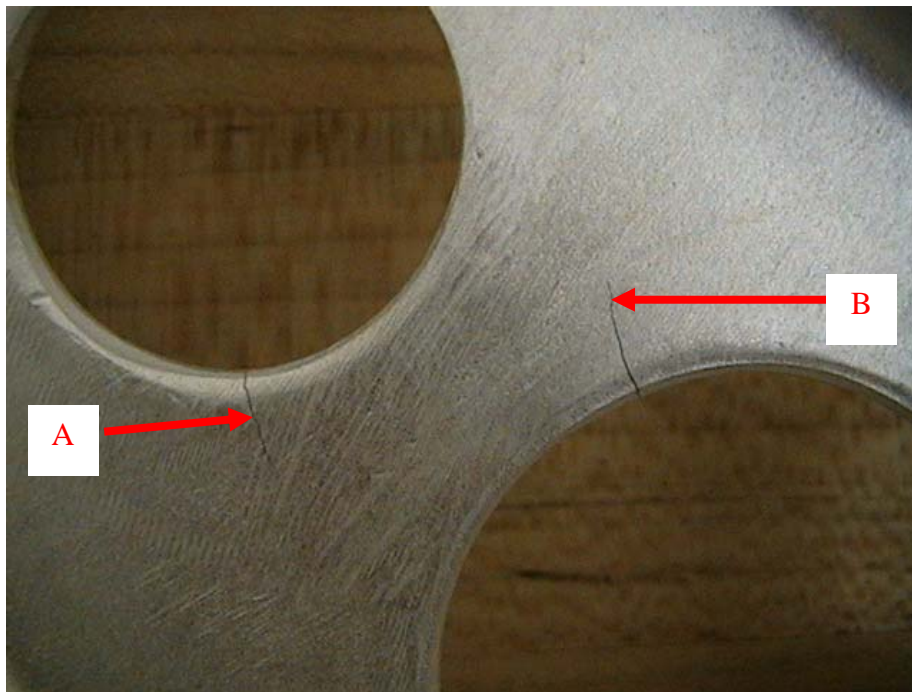
Both tip tank fittings had areas of cracking. The left wing tip tank baffle, shown in figure 9, had two cracks measuring 0.252 and 0.295 inch, which were both caused by fatigue. The right wing tip tank fitting had several cracks, which were apparently induced during manufacturing due to the heat treatment process.

Figure 9. Two Cracks in the Cessna 402A Left Wing Tip Tank Baffle

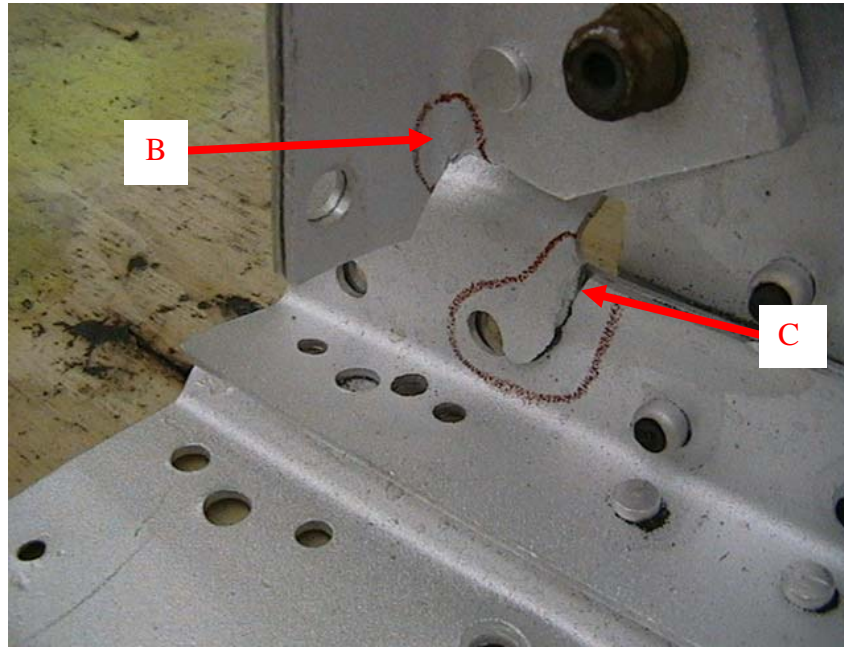
All four auxiliary spars had multiple cracks. Eight total cracks were found on the left wing auxiliary spars, ranging from 0.046 to 0.598 inch. Twelve total cracks were found on the right wing auxiliary spars, ranging from 0.041 to 0.74 inch. All auxiliary spar cracks show signs of typical fatigue cracks. Figures 10 and 11 show examples of the 20 total cracks found on the wing auxiliary spars.

Figure 10. Two Cracks Found on the Cessna 402A Left Wing Forward Auxiliary Spar

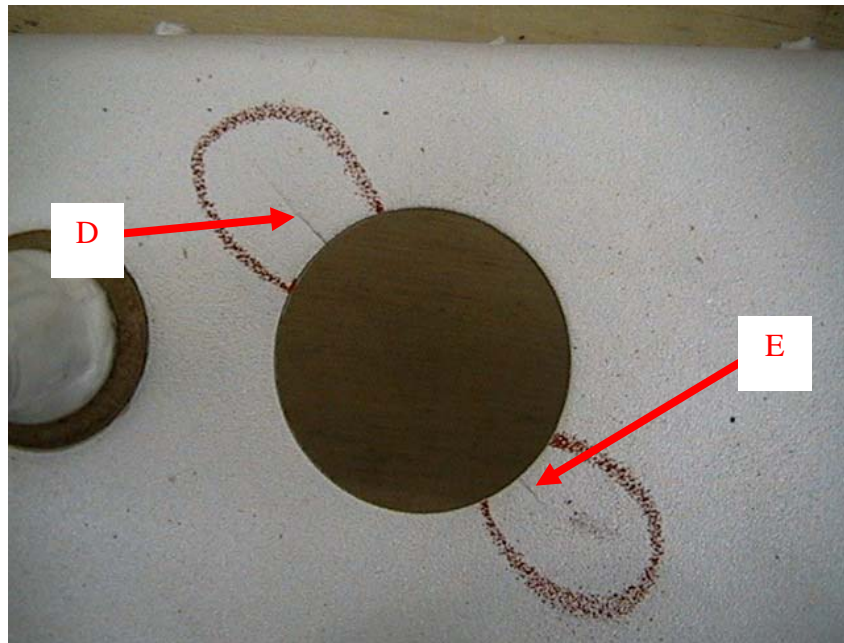
Figure 11. Cracks Around Lightening Hole on the Cessna 402A Left Wing Forward Auxiliary Spar

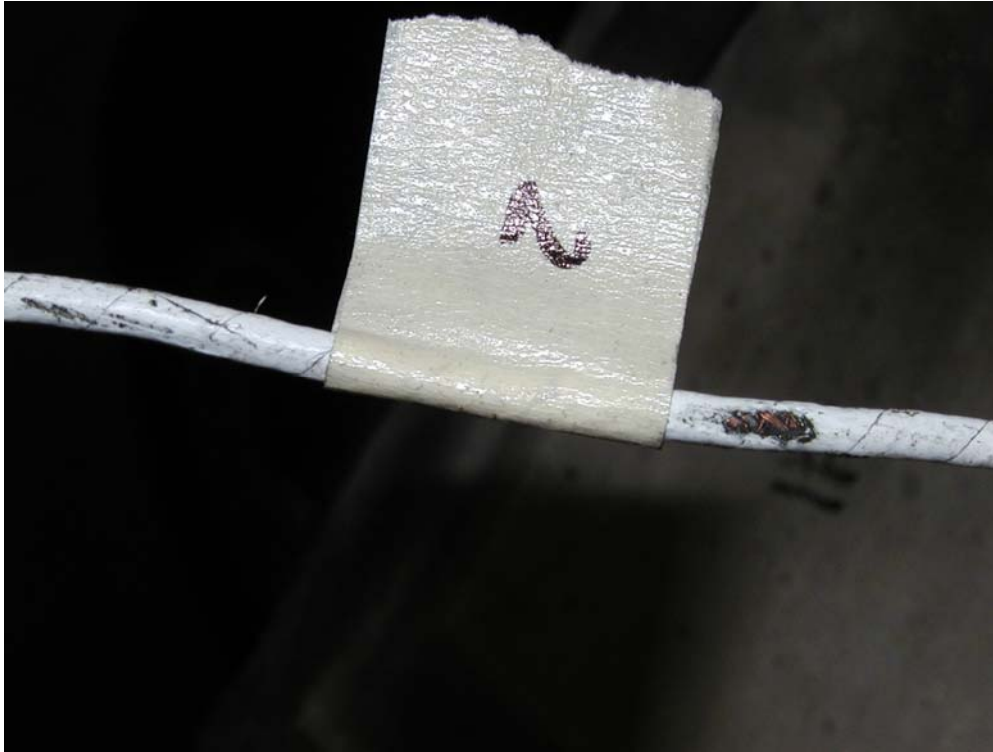
Figure 12. Exposed Inner Conductor in the Cessna 402A Engine Compartment

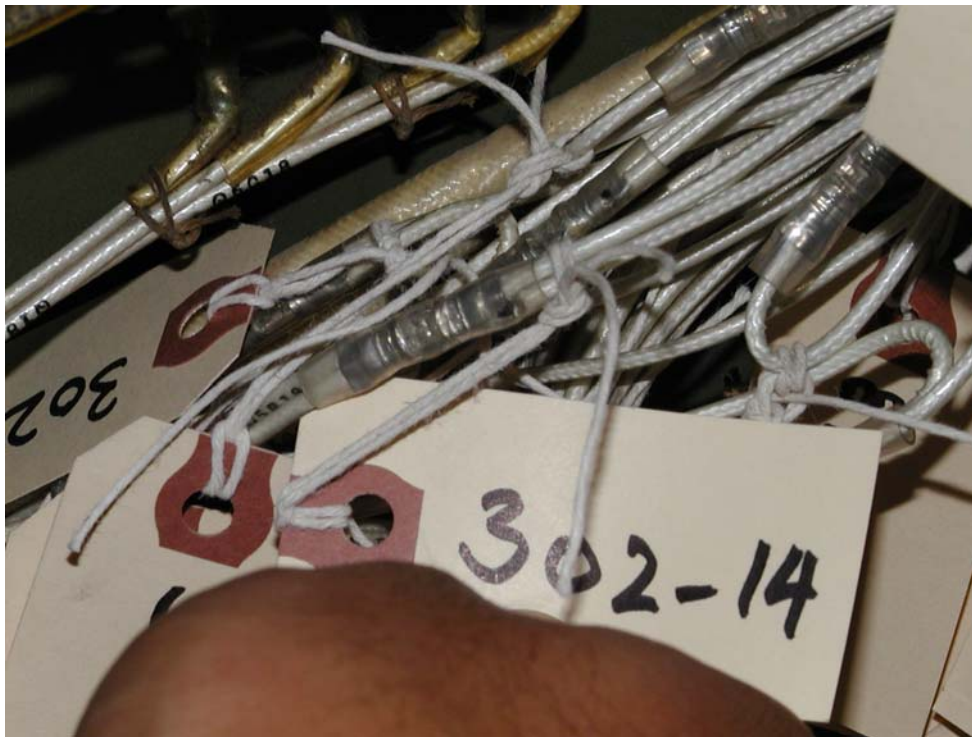
Figure 13. Repaired Wires in the Cessna 402A Side Console

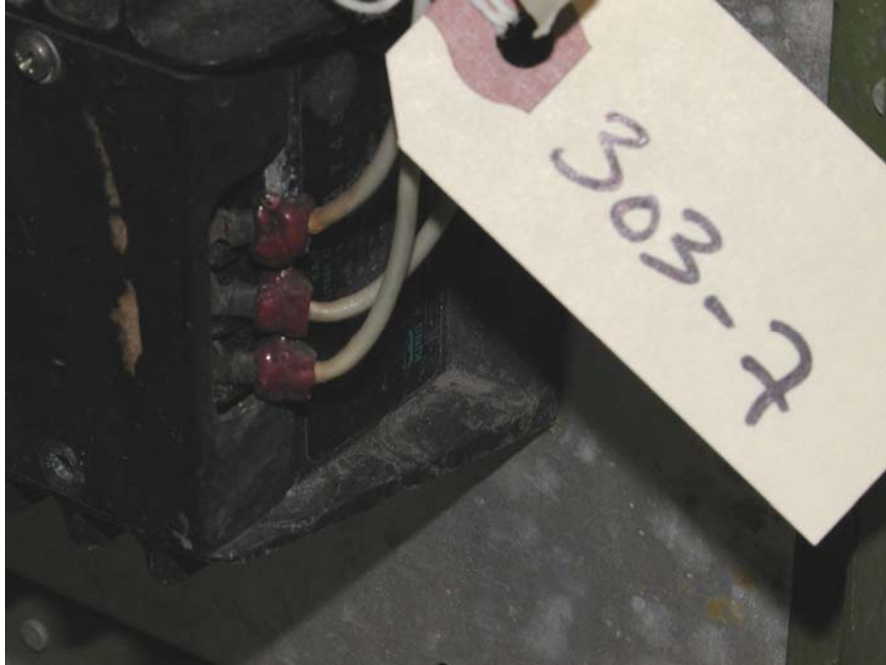
Figure 14. Heat-Damaged Terminals in the Cessna 402A Nose Compartment

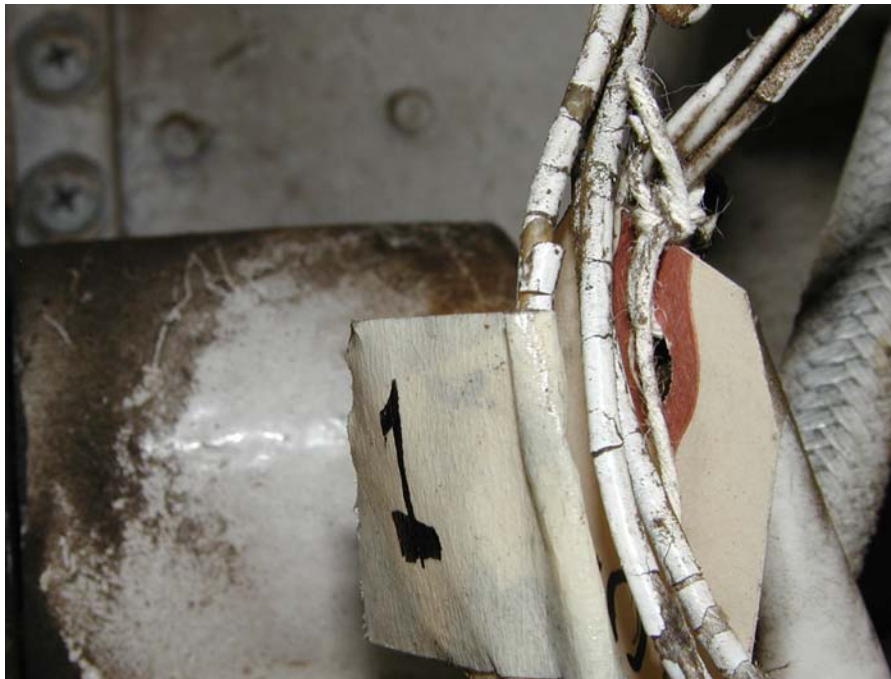
Figure 15. Cracked Wires in the Cessna 402A Landing Gear

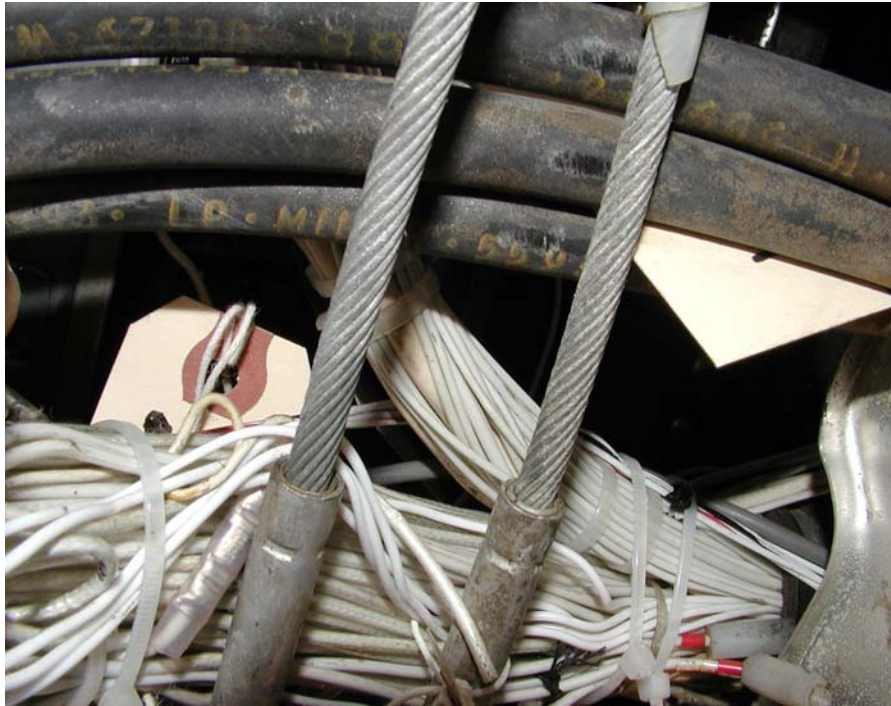
Figure 16. Wire Bundles Riding on the Cessna 402A Control Cables

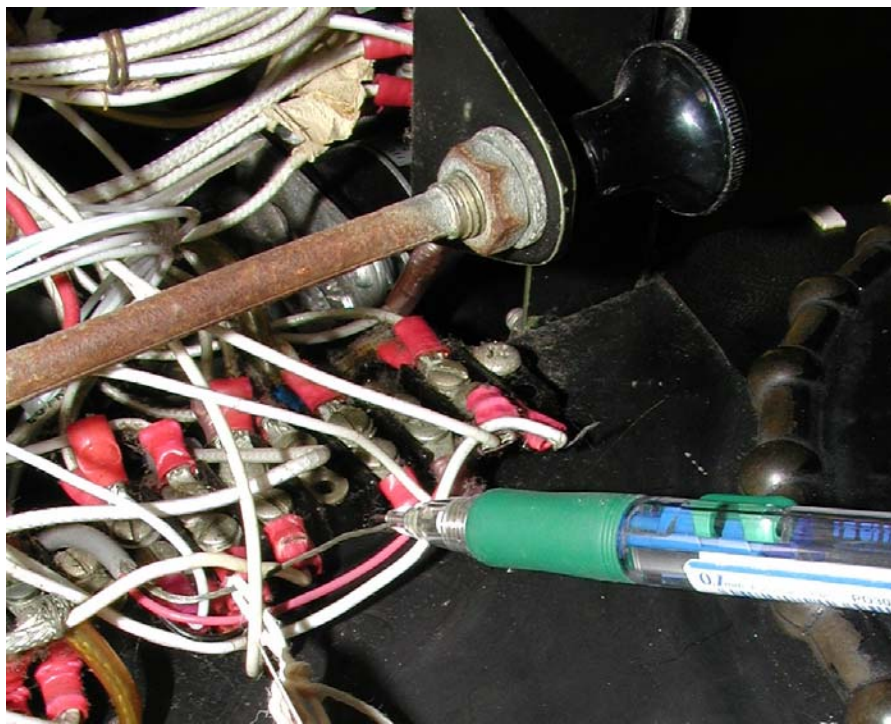
Figure 17. Partially Stripped Wire in the Cessna 402A Instrument Panel

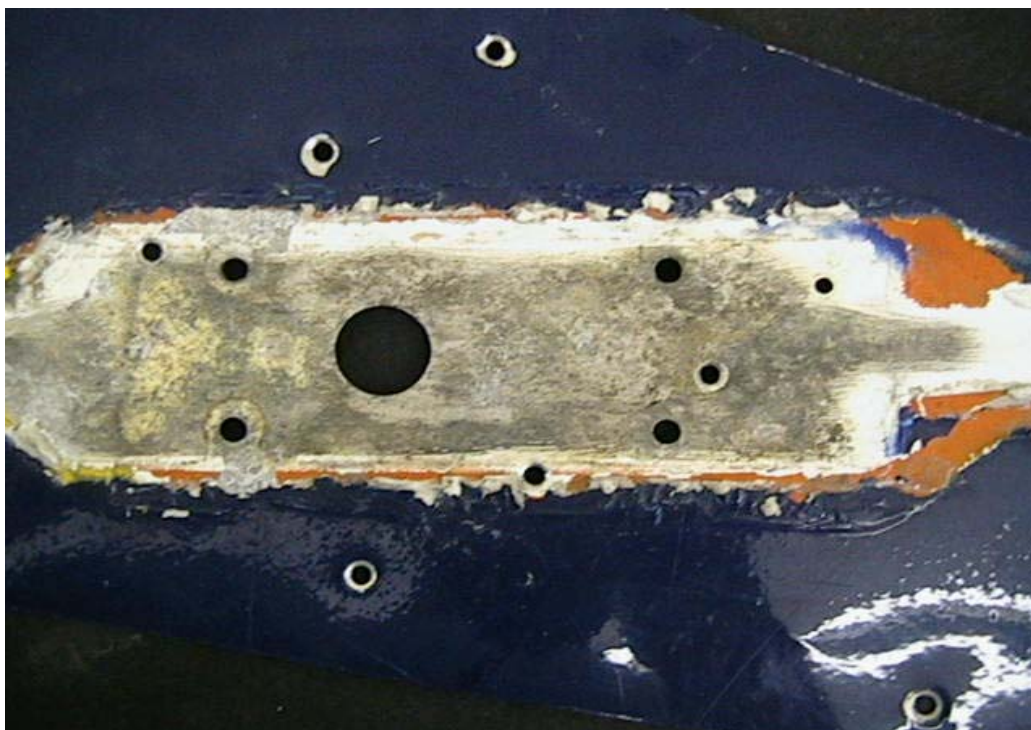
Three defects noted by the inspectors were determined to be more serious in nature. A static leak was observed in a hydraulic flow pressure switch. The right exhaust pipe was improperly repaired with a welded plate patch. When maintenance technicians from Cape Air removed the antenna (part number VT10-56-5) from the vertical stabilizer, they found that the skin had a significant area of corrosion. The antenna is not removed as part of any inspection; therefore, the area of corrosion, which is shown in figure 19, would not have been found during any prescribed visual or supplemental inspections.

Figure 19. Corrosion on the Cessna 402C Vertical Stabilizer Skin Common to the Antenna

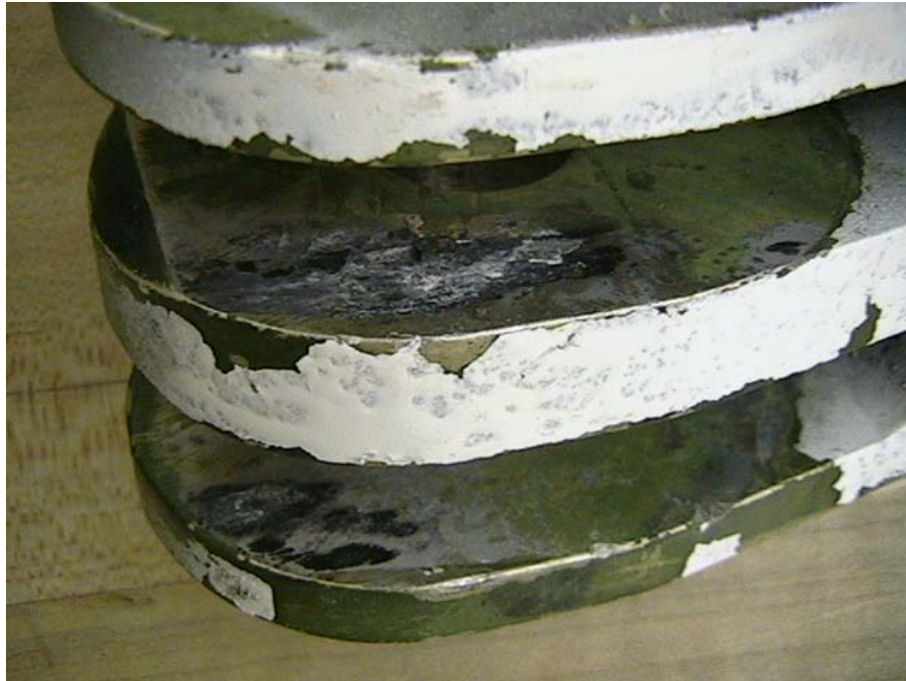
Figure 20. Corrosion Observed on the Cessna 402C Stub Wing Spar Attachment Fittings

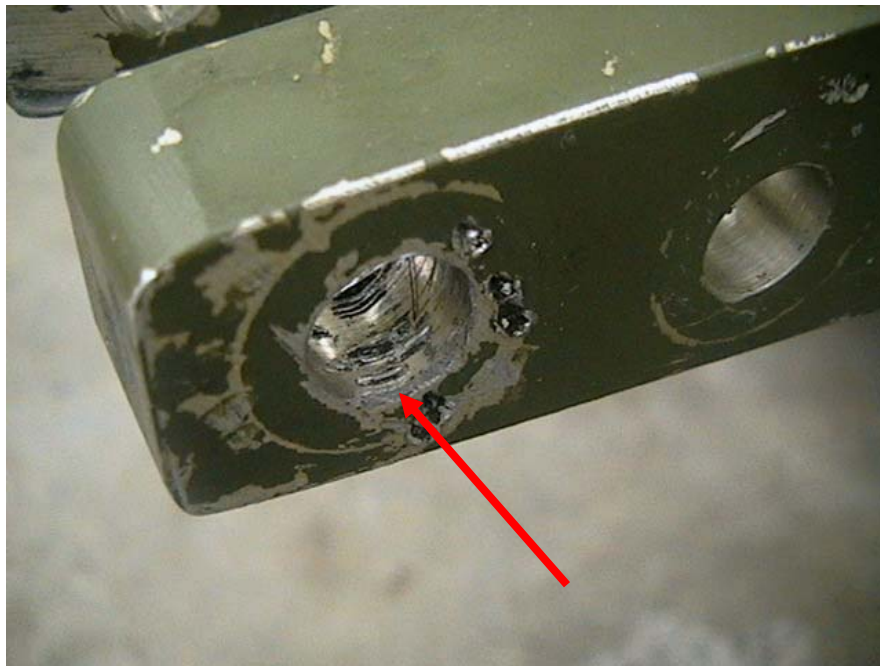
Figure 21. Example of Damage Induced During Removal of the Cessna 402C Stub Wing Attachment Fittings

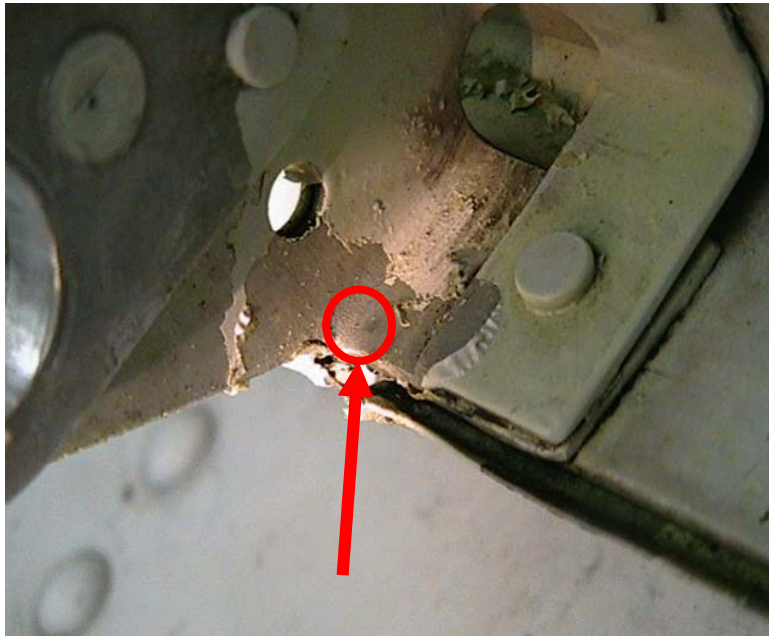
Figure 22. Crack in the Bracket Supporting Cessna 402C Left Inboard Elevator Attach Fitting

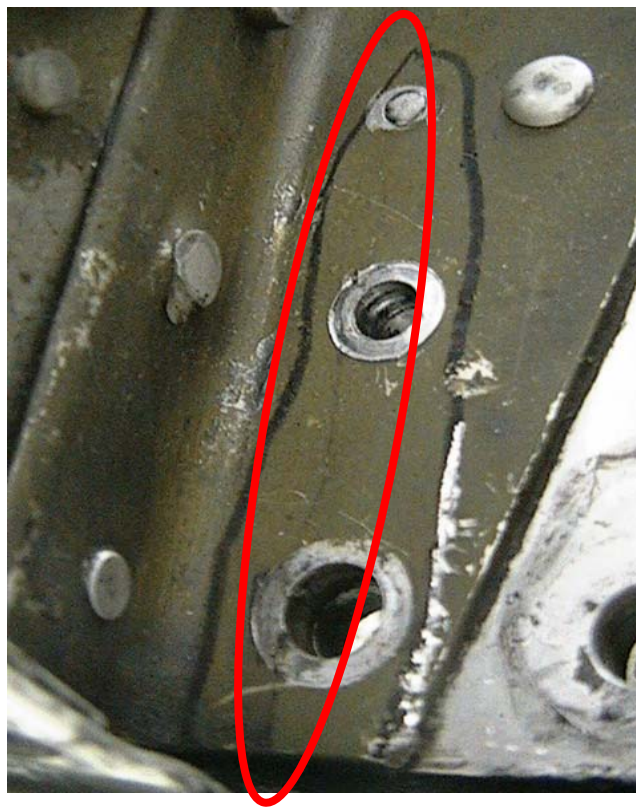
attachment fitting. Figure 23 shows a 2-inch crack found on an angle common to the right stub wing outboard rib and the carry-through structure during the bolthole eddy-current SID inspections.

Figure 23. Crack in the Cessna 402C Angle Common to the Right Stub Wing Rib and Carry-Through Structure

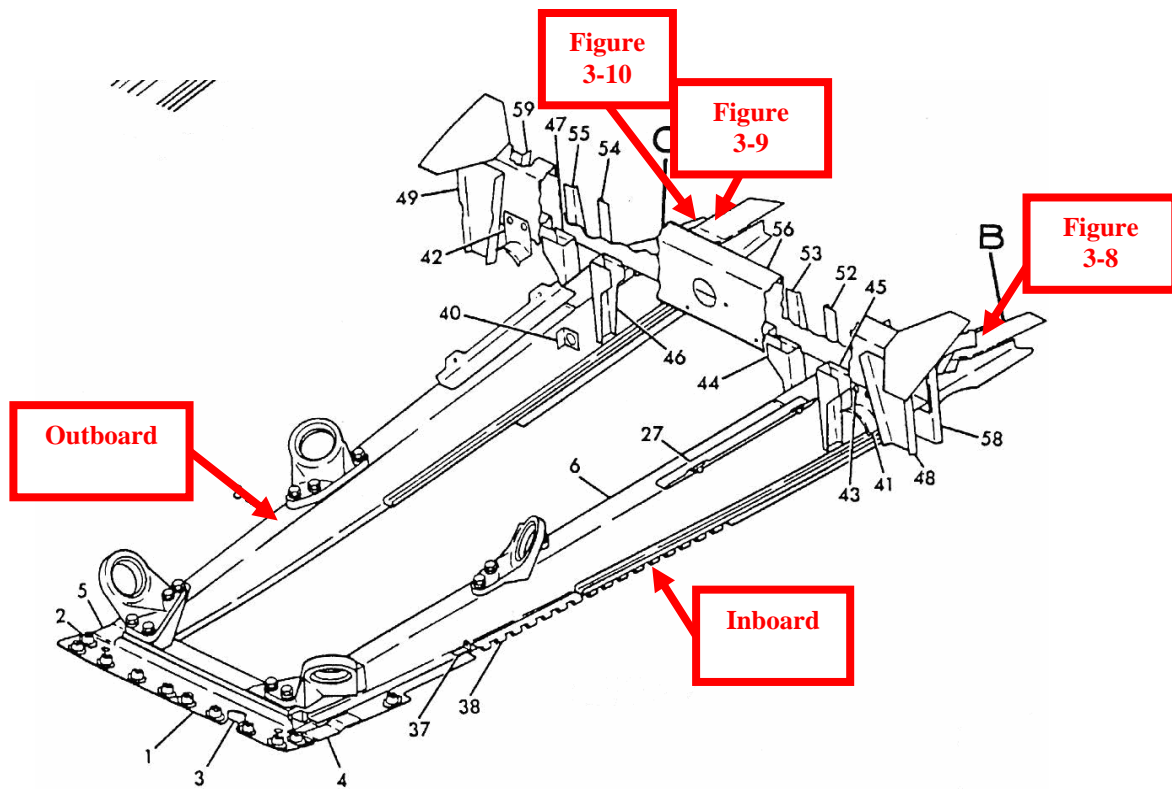
Figure 25 shows the right wing engine structure. The listed figure numbers refer to detailed pictures of the cracks found in the right wing engine beam structure. Figure 26 shows a crack found on the channel of the inboard engine beam. This crack runs completely across the channel almost parallel to the front spar on the upper surface of the channel, and it continues across the outboard flange of the inboard engine beam. Figure 27 shows a 2.062-inch-long crack found on the channel of the outboard engine beam that runs along the inboard upper side perpendicular to the front spar. A similar 1.437-inch-long crack was also found on the left outboard engine beam. Figure 28 shows a crack on the angle bracket on the outboard right nacelle beam. This crack runs mostly perpendicular to the front spar. Additional damage was found between the right inboard engine beam and its attachment location on the right lower front spar. The skin was worn completely through, and the spar cap itself exhibited evidence of wear, as seen in figure 29.

Figure 25. Location of Cracks on the Cessna 402C Right Wing Engine Beams

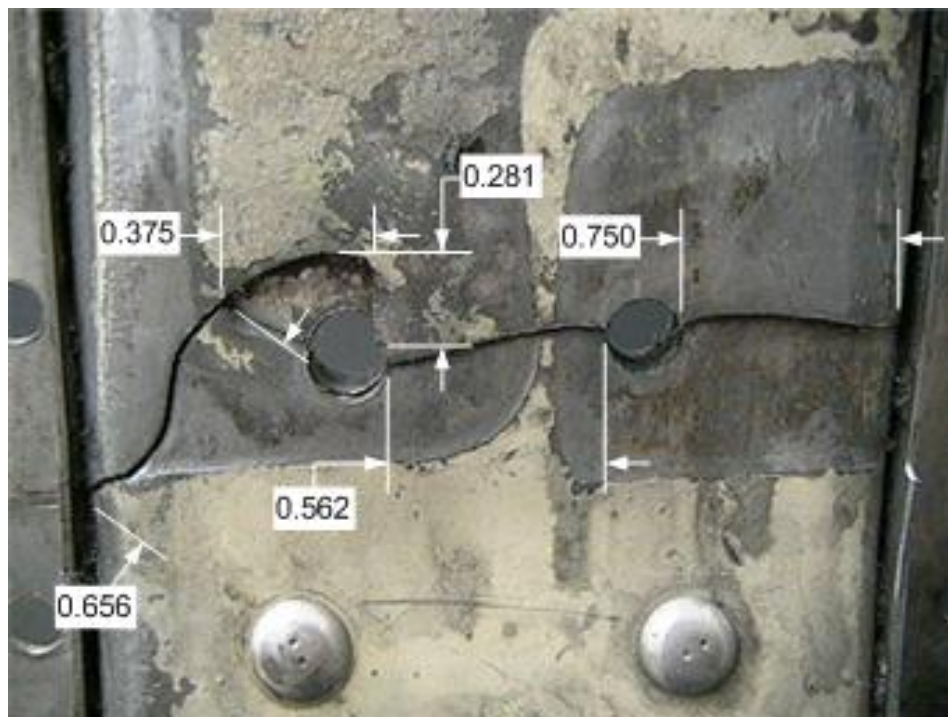
Figure 26. Cracked Cessna 402C Right Wing Inboard Engine Beam

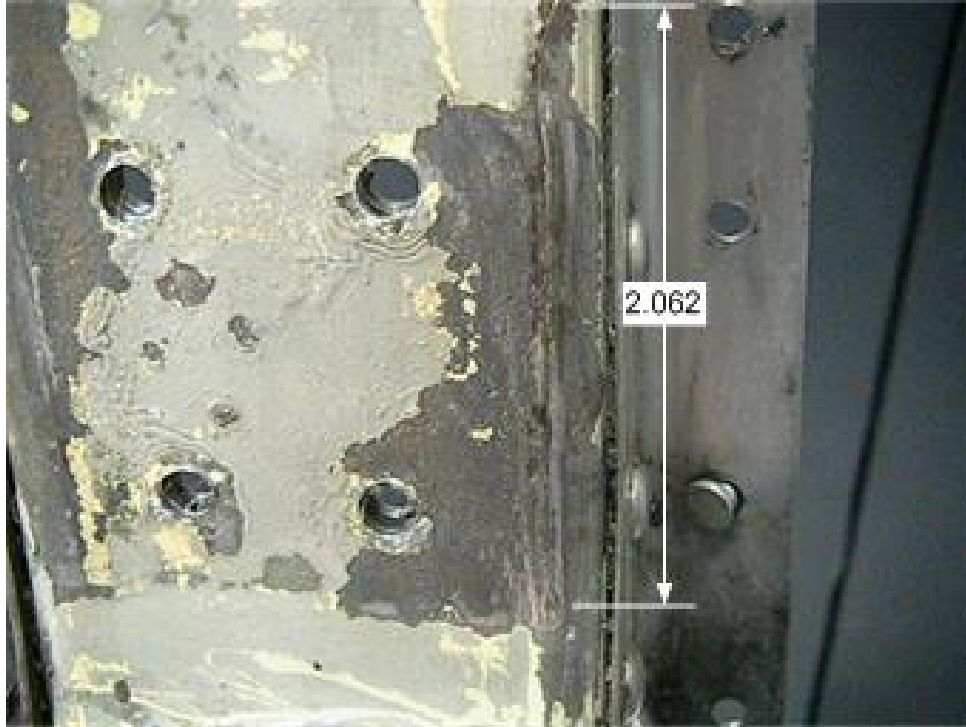
Figure 27. Cracked Cessna 402C Inboard Upper Surface of the Right Wing Outboard Engine Beam

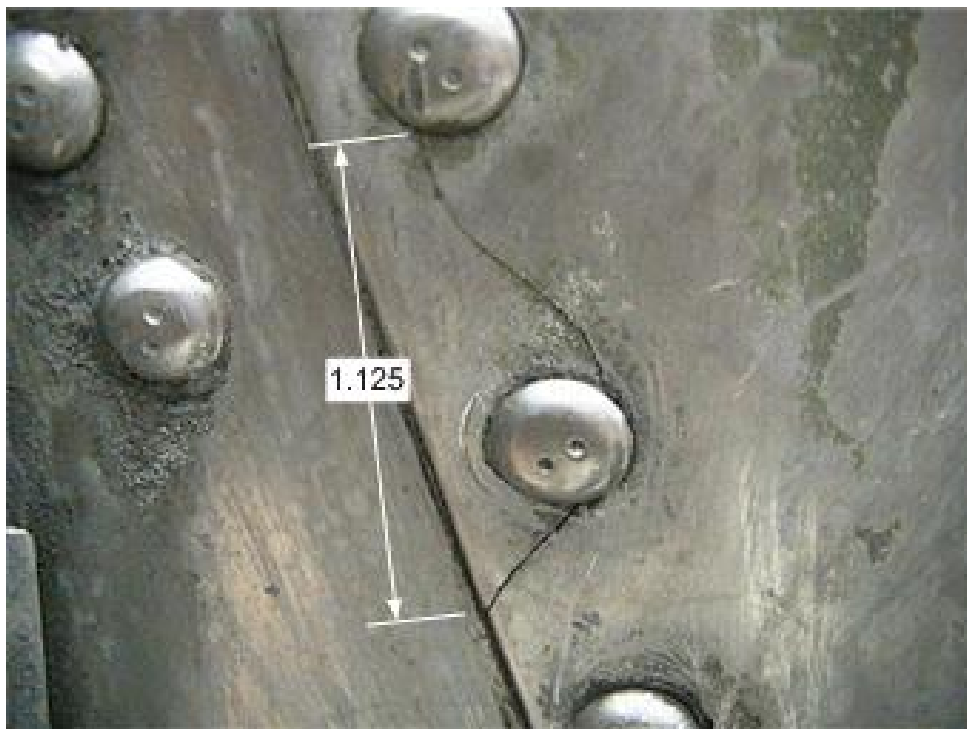
Figure 28. Cracked Cessna 402C Angle Bracket of the Right Wing Outboard Engine Beam

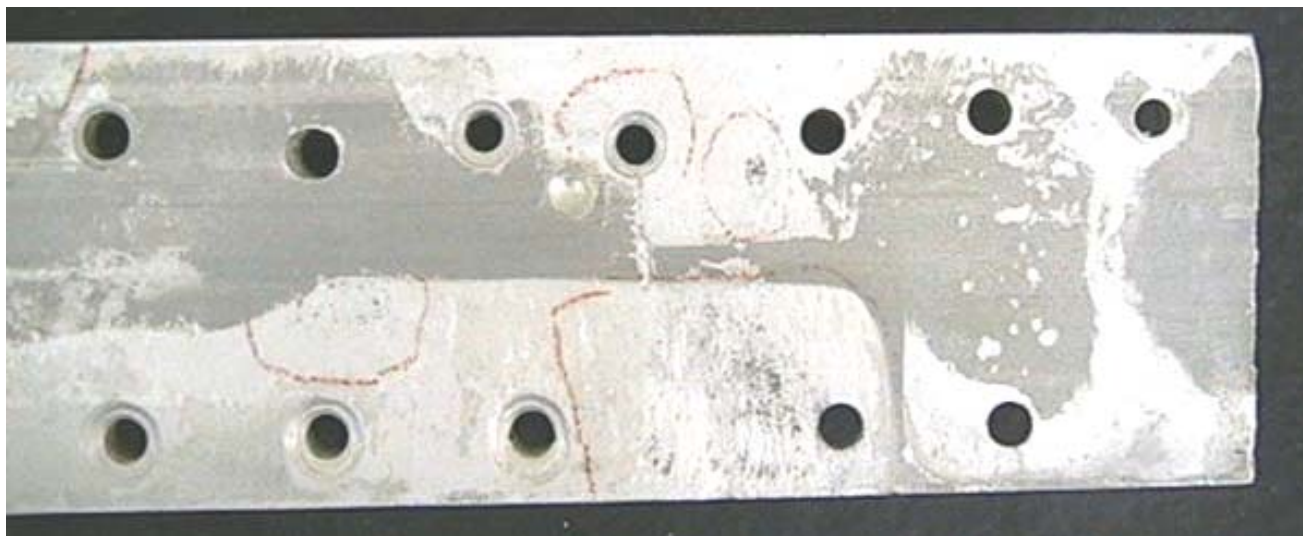
Figure 29. Wear on the Cessna 402C Right Wing Front Spar Lower Cap

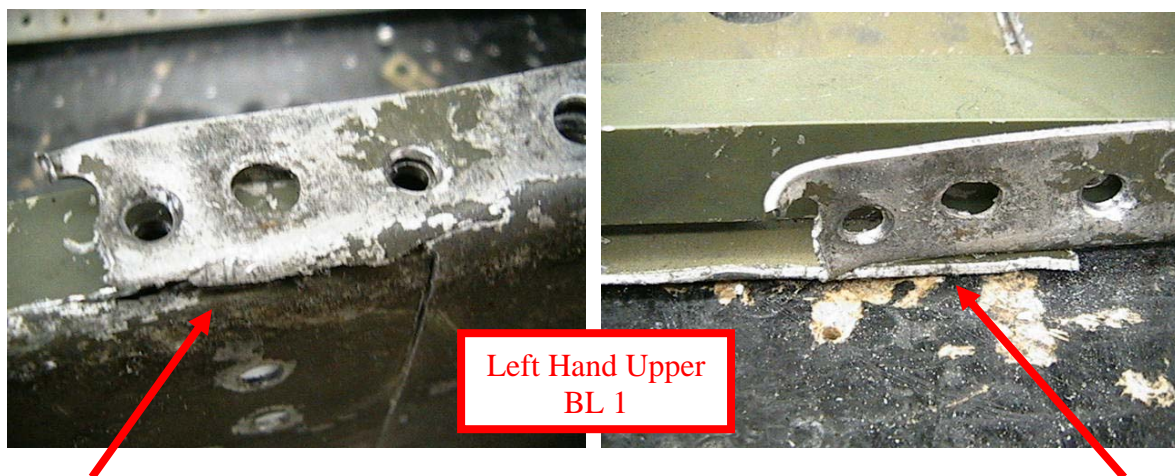
Figure 31. Crack in the Aft Carry-Through Forward Web

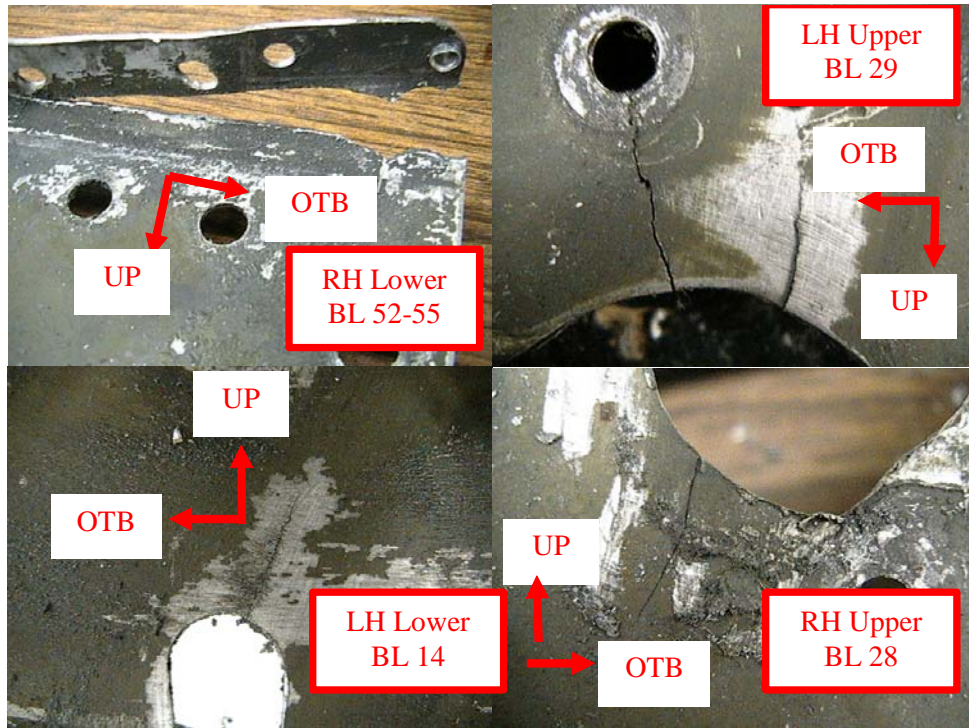
Figure 32. Cracks in the Forward Carry-Through Forward Web

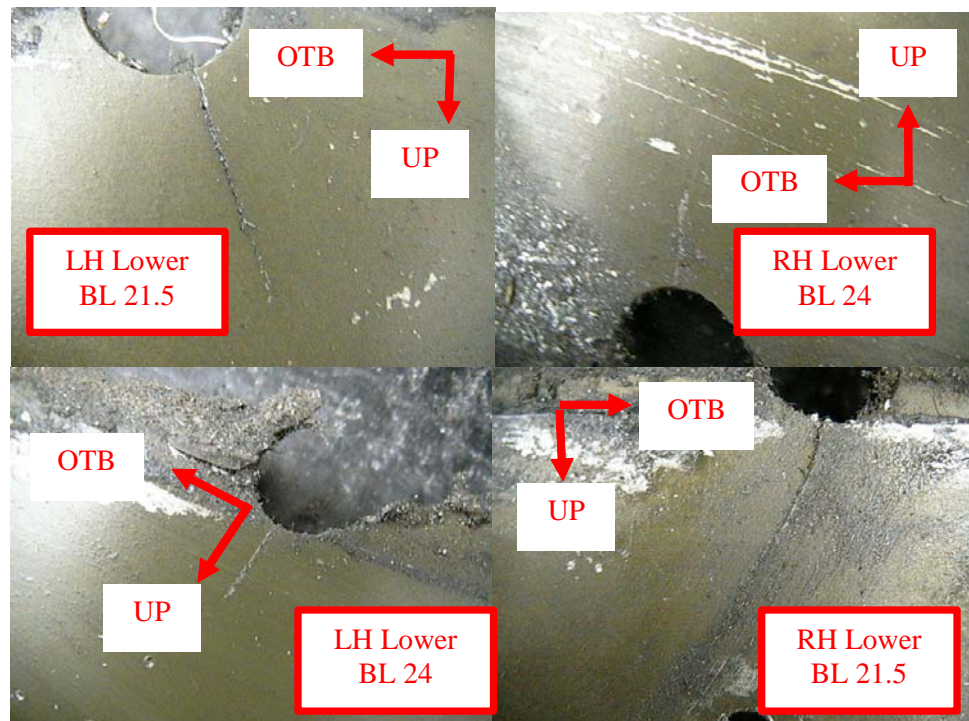
Figure 33. Cracks in the Forward Carry-Through Aft Web

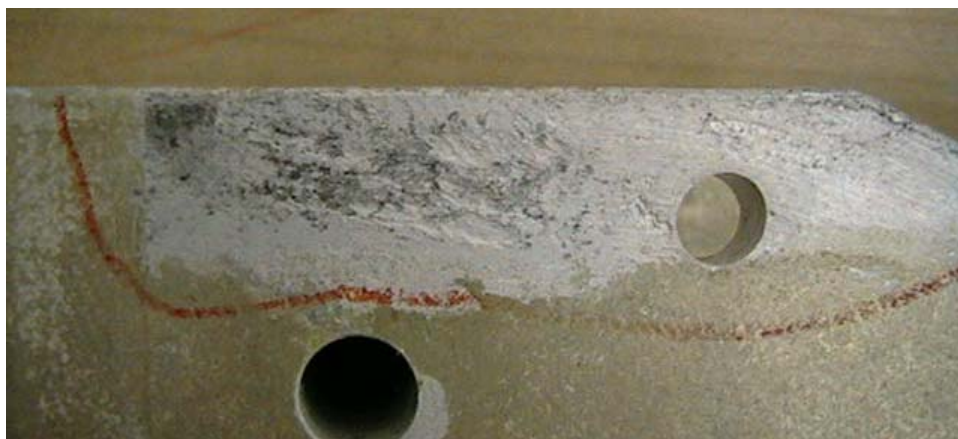
Seven of the eight stub wing attach fittings were found to have corrosion. In general, the corrosion on the aft fittings was relatively light, but the forward fittings had much more corrosion on them, primarily at the attach points. Figure 34 shows an area of corrosion on the left stub wing forward lower attach fitting, while an area of corrosion located on the right stub wing forward attach fitting is shown in figure 35.

Figure 34. Area of Corrosion on the Cessna 402C Left Stub Wing Forward Lower Attach Fitting

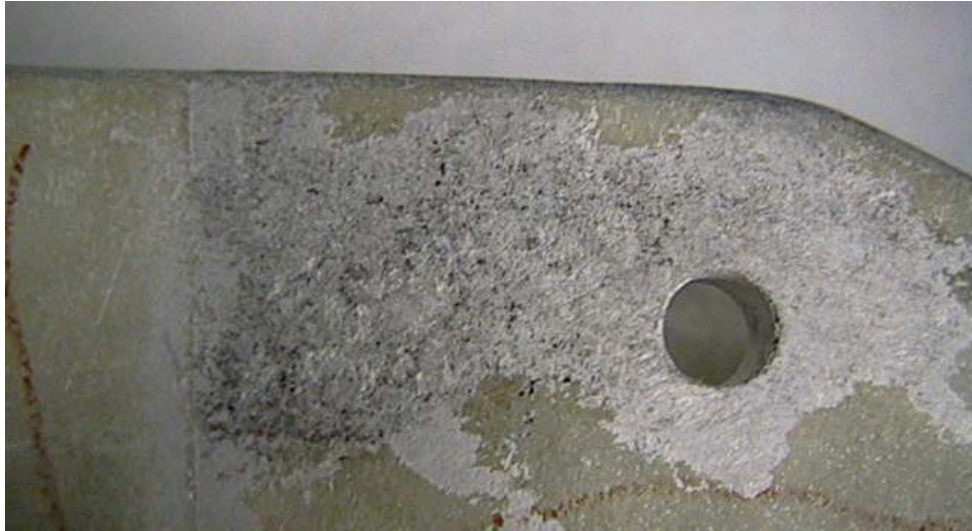
Figure 35. Area of Corrosion on the Cessna 402C Right Stub Wing Forward Upper Attach Fitting

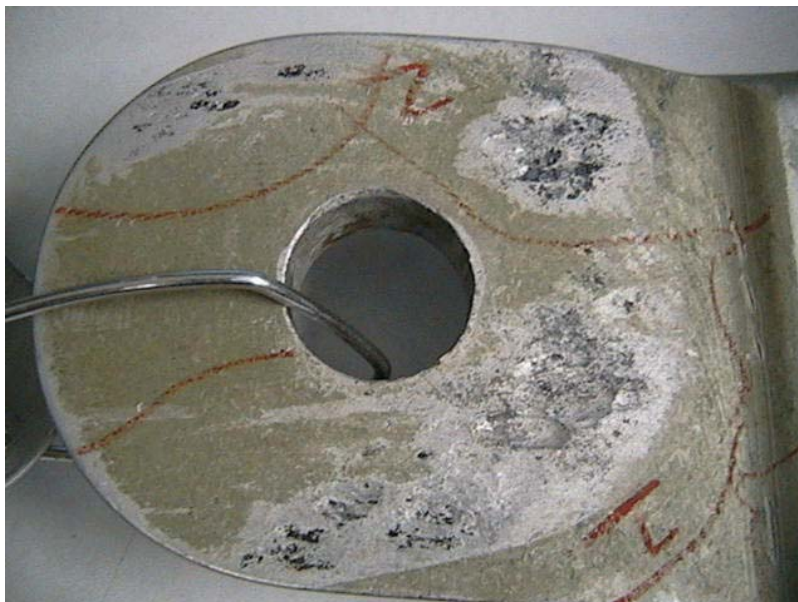
All wing attach fittings had corrosion in several areas. The most significant corrosion was located around the attach points, but slight corrosion was found on different areas of the fittings. Several fastener holes had areas of metal separation due to mechanical damage incurred during the removal of the fasteners. Figure 36 shows an area of corrosion on the right wing forward upper attach fitting near the attachment point, while figure 37 shows an area of corrosion near the attachment point on the left wing lower attachment fitting.

Figure 36. Area of Corrosion on the Cessna 402C Right Wing Forward Upper Attach Fitting

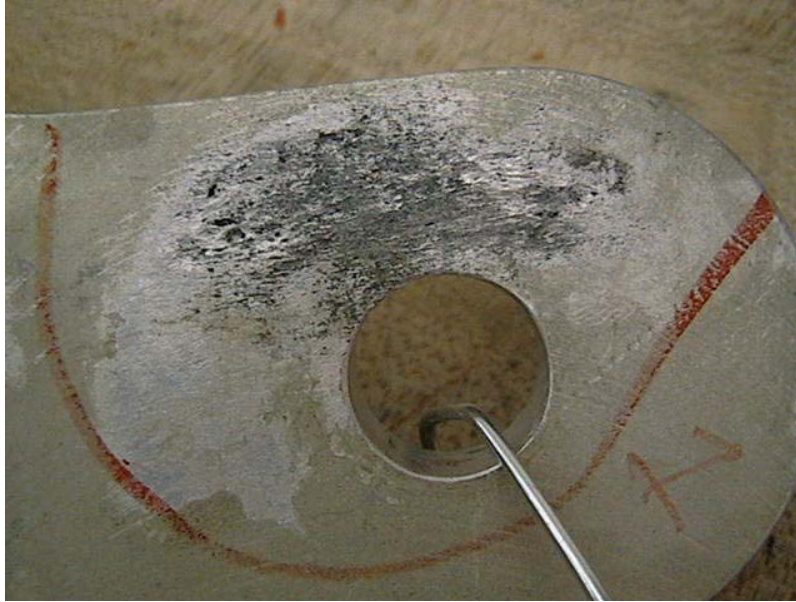
Figure 37. Area of Corrosion on the Cessna 402C Left Wing Lower Attach Fitting
