DOT/FAA/AR-07/35

Summary and Comparison Report on Teardown Evaluation of Cessna 402A and Cessna 402C Airplanes

June 2007

Final Report

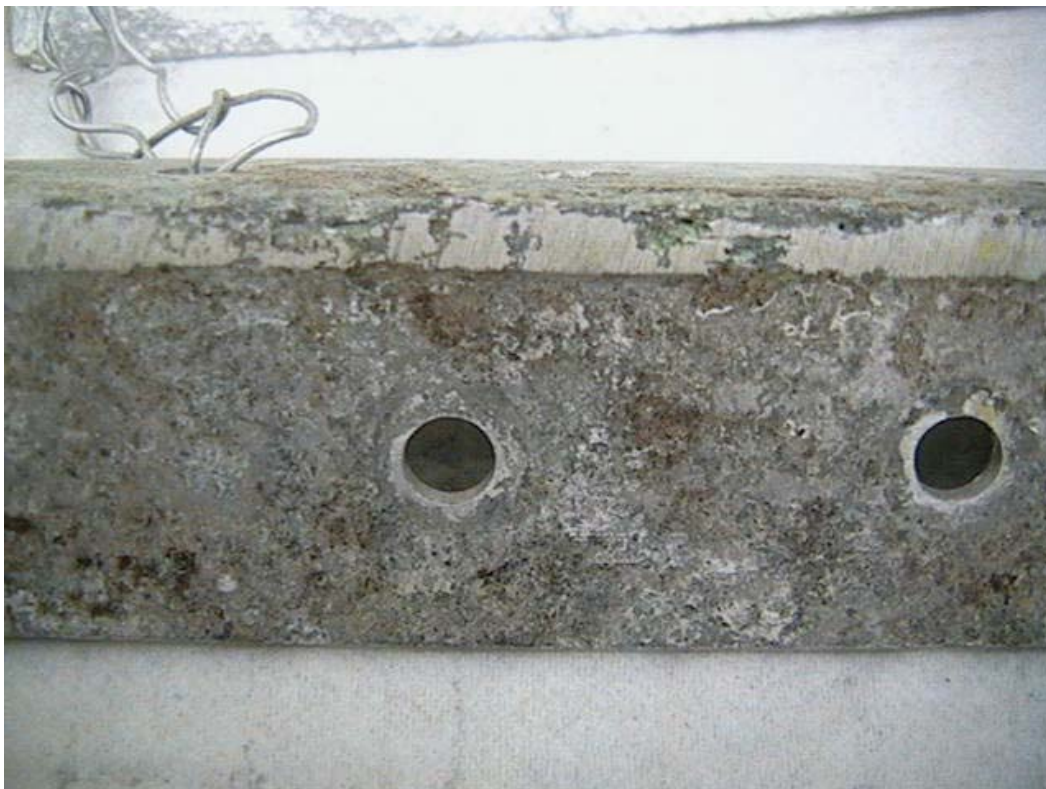
Corrosion was found on the wings in multiple areas, with both front and rear spars having the most areas of corrosion. On the whole, the left wing rear spar tended to be the most corroded, with areas up to 25% thickness loss. Figure 38 shows one of the more severe areas of corrosion observed on the left wing rear spar lower cap. Another area of corrosion, pictured in figure 39, was observed on the left wing rear spar upper cap. The remainder of the spars had scattered areas of 0%-10% corrosion, with the outboard sections of the rear spars having the most corrosion in general. Several areas of the wing spars looked as if they had not been anodized, which could be a cause for the severe corrosion. Slight corrosion was observed on the auxiliary spars, but it was loosely scattered. In total, 50 wing parts were found to have some type of defect.

Figure 38. Area of Corrosion on the Cessna 402C Left Wing Rear Spar Lower Cap

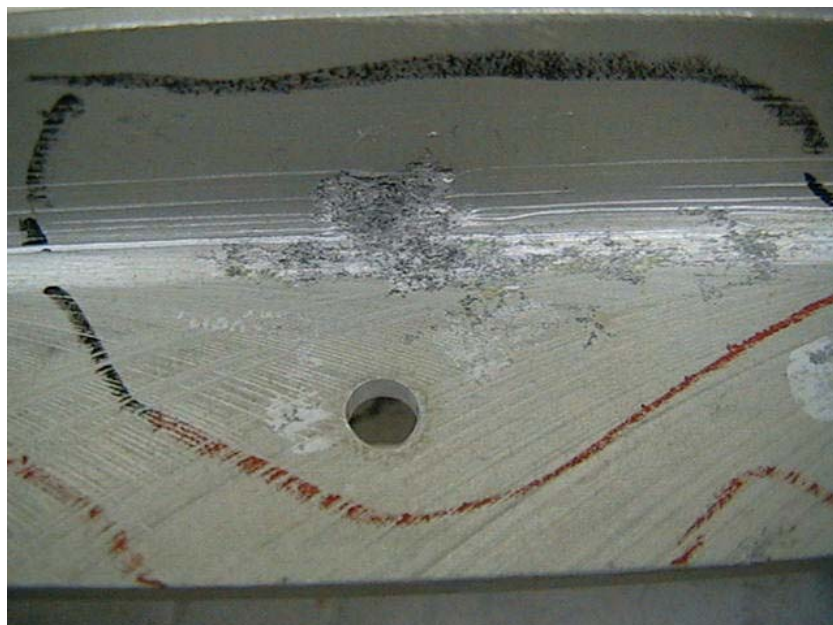
Figure 39. Area of Corrosion on the Cessna 402C Left Wing Rear Spar Upper Cap

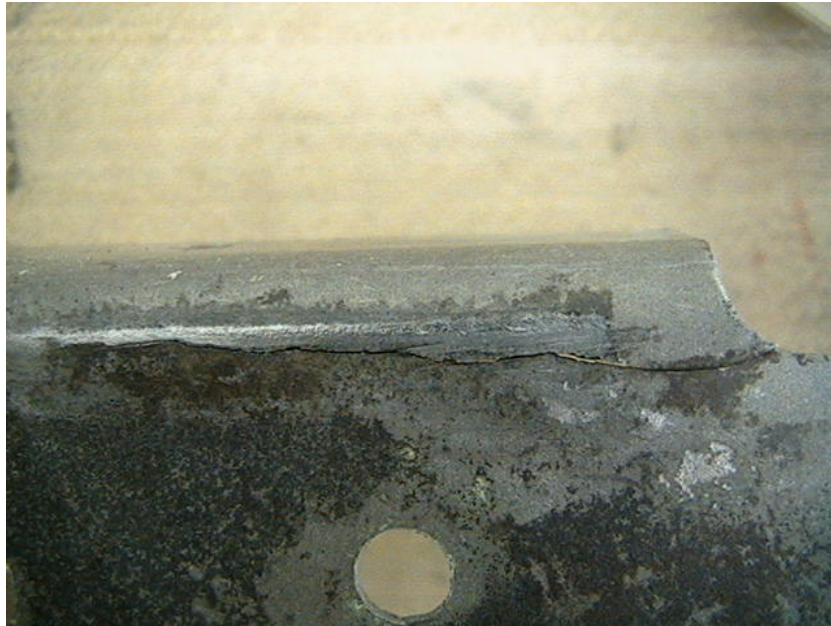
The engine beam assemblies had a total of 25 cracks and several areas of corrosion. This corrosion was slight, but some of the cracks were deemed potentially unsafe. All of the cracks

were caused by fatigue. Figure 40 shows a longitudinal crack on the left wing outboard engine beam. A crack that traverses the right wing inboard engine beam is pictured in figure 41, while a longitudinal crack on the right wing outboard engine beam is shown in figure 42.

Figure 40. Crack on the Cessna 402C Left Wing Outboard Engine Beam

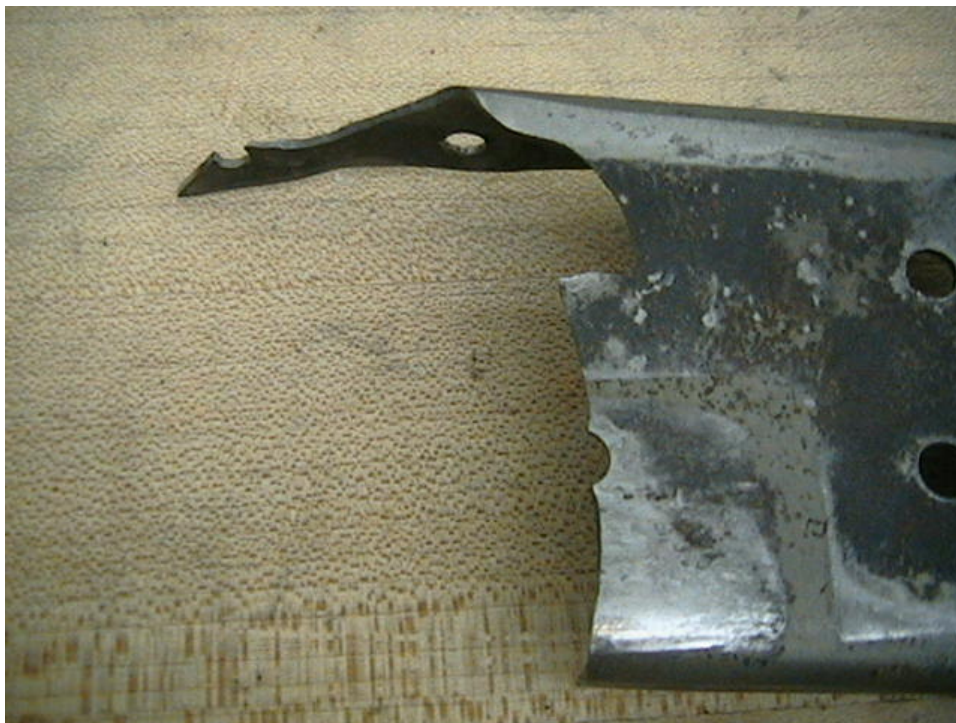
Figure 41. Crack Across Cessna 402C Right Wing Inboard Engine Beam

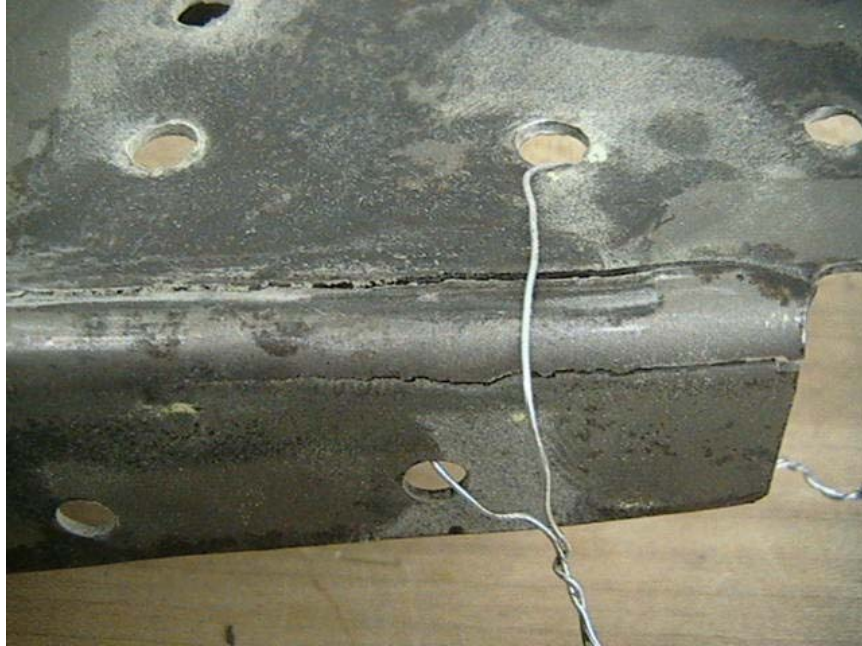
Figure 42. Crack in the Cessna 402C Right Wing Outboard Engine Beam

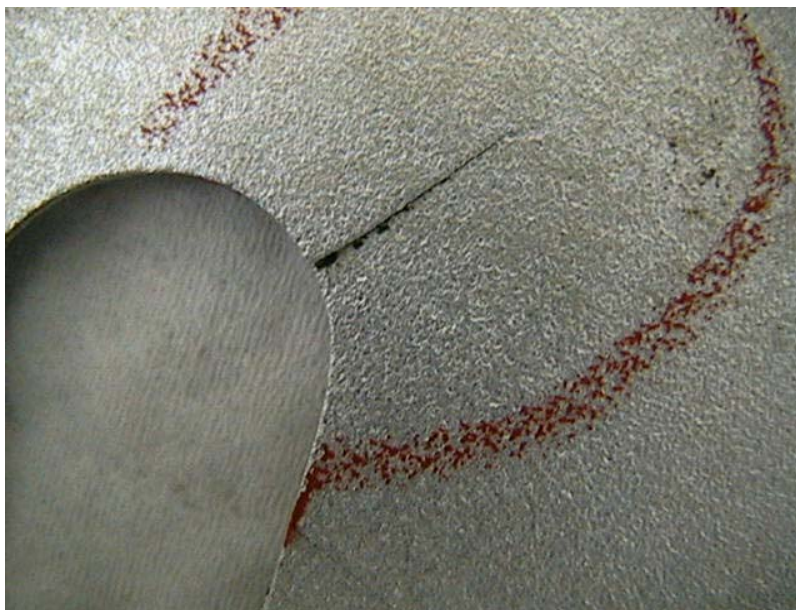
The carry-through beams had some areas of mostly light surface corrosion with just a few areas of slightly deeper corrosion. The carry-through webs had a total of 43 cracks, an example of which is shown in figure 43. Two additional cracks were also found on the left stub wing outboard rib where a cable pulley was attached, as shown in figure 44. The cracks found on the rib were caused by fatigue. On the right stub wing, an angle, shown in figure 45, that was found cracked during the SID inspection, was determined to be caused by fatigue.

Figure 43. Crack in the Cessna 402C Carry-Through Aft Web

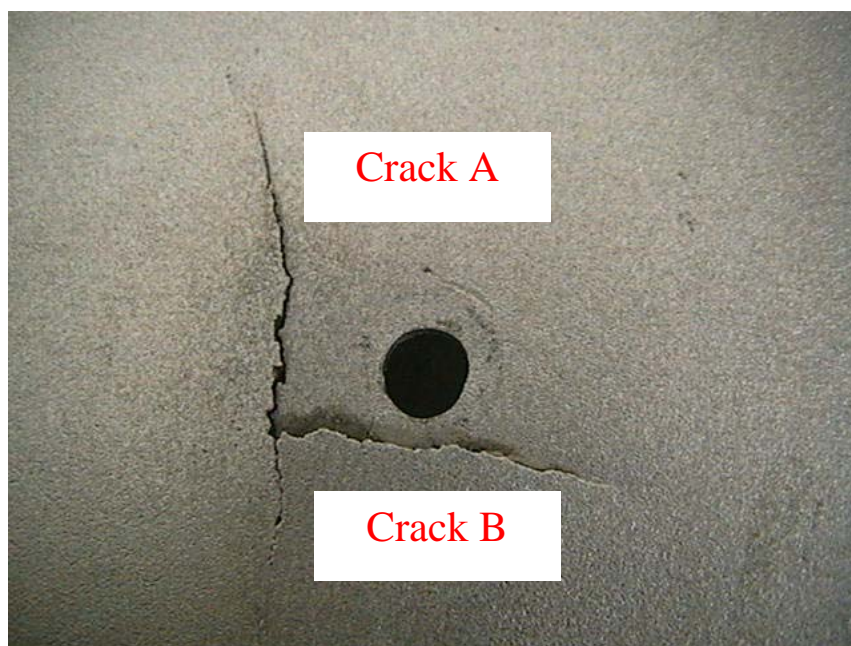
Figure 44. Cracks on the Cessna 402C Left Stub Wing Rib

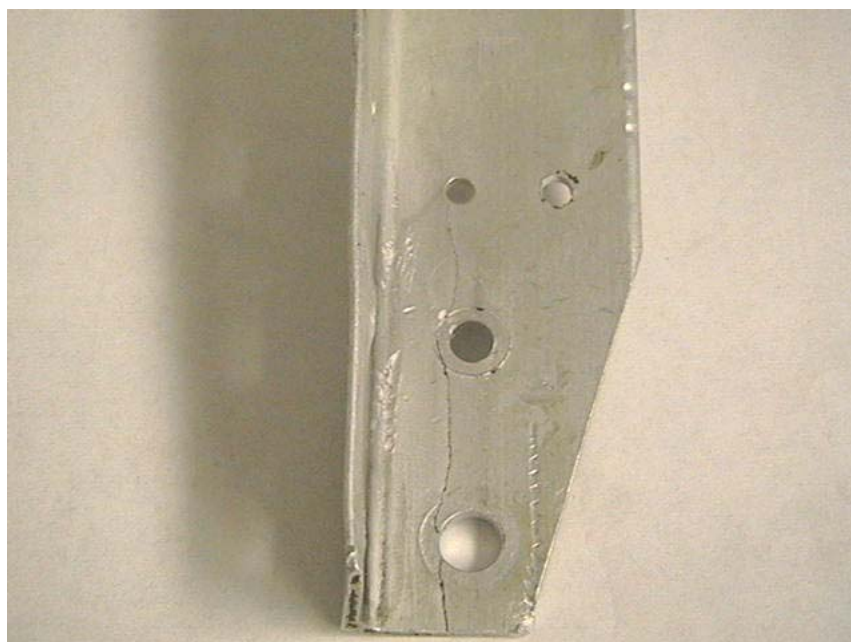
Figure 45. Crack in the Cessna 402C Right Stub Wing Angle Common to the Outboard Rib and Carry-Through Structure

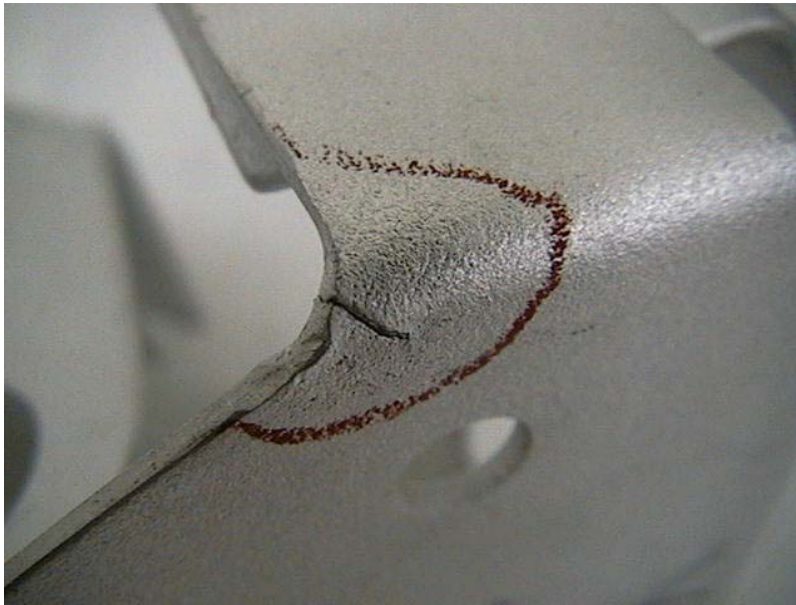
The front and rear spars of the horizontal stabilizer were inspected, as well as the elevator attach fittings. One crack, shown in figure 46, found on a bracket supporting the elevator attach fitting, was caused by fatigue. Light corrosion was found scattered on the front and rear spars of the

Figure 46. Crack on the Cessna 402C Left Inboard Elevator Attach Bracket

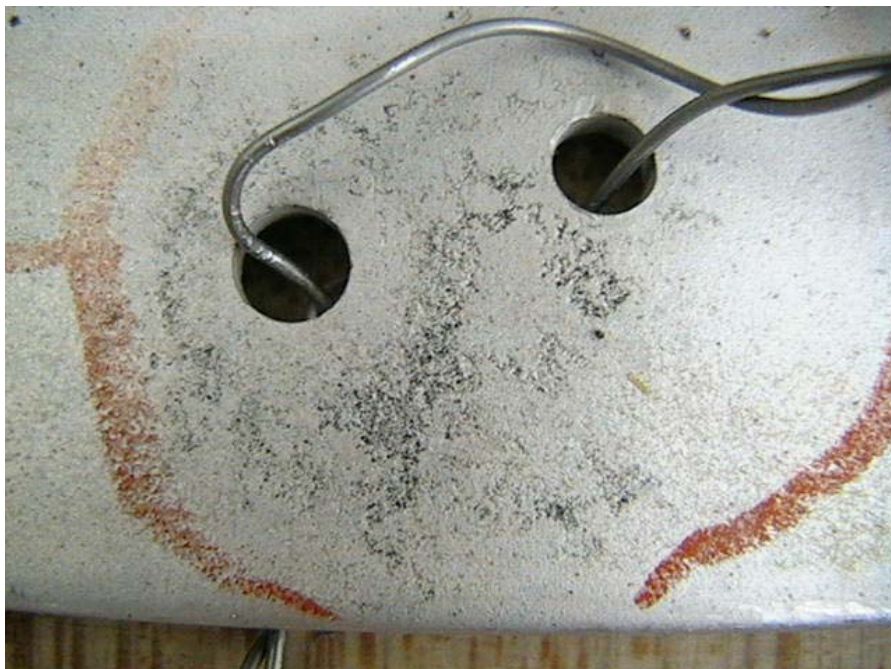
horizontal stabilizer. An example of the corrosion observed on the horizontal stabilizer is shown in figure 47.

Figure 47. Corrosion on the Cessna 402C Horizontal Stabilizer Rear Spar Lower Cap

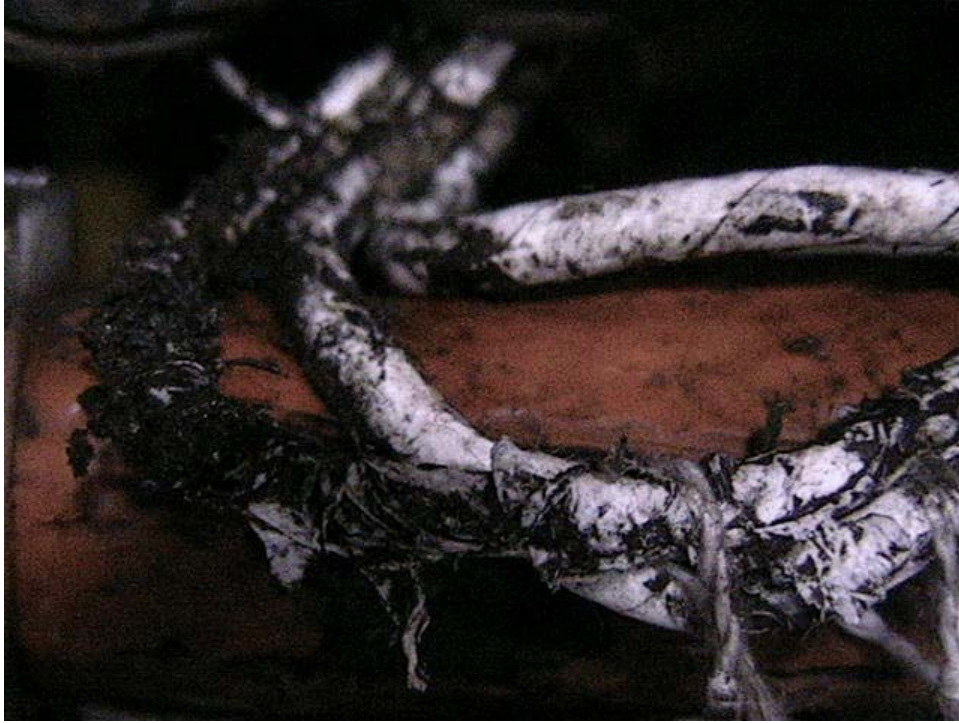
Figure 48 shows worn and dirty wires found in the right engine compartment, while figure 49 shows an exposed inner conductor on a wire in the right engine compartment. A damaged shield due to cut outer insulation in the right engine is shown in figure 50. Figure 51 shows a damaged outer shield in the left engine, while figure 52 shows grease contamination at the splices in the left engine. A broken connection in the right console is shown in figure 53, while a heat-damaged inner conductor in the right console is shown in figure 54. Figure 55 shows a wire bundle that damaged an air inlet in the forward bulkhead region due to improper clearance. Dust contamination and an example of an improper bend radii found in the baggage compartment are shown in figures 56 and 57, respectively. Figure 58 shows unused wires improperly stowed in the upper bulkhead region. A heat-damaged wire found in the tail section is shown in figure 59, while a wire with cracked insulation found in the cockpit floor is shown in figure 60. An example of improper clamp size in the instrument panel region is shown in figure 61.

Figure 48. Worn and Dirty Wires in the Cessna 402C Right Engine Compartment

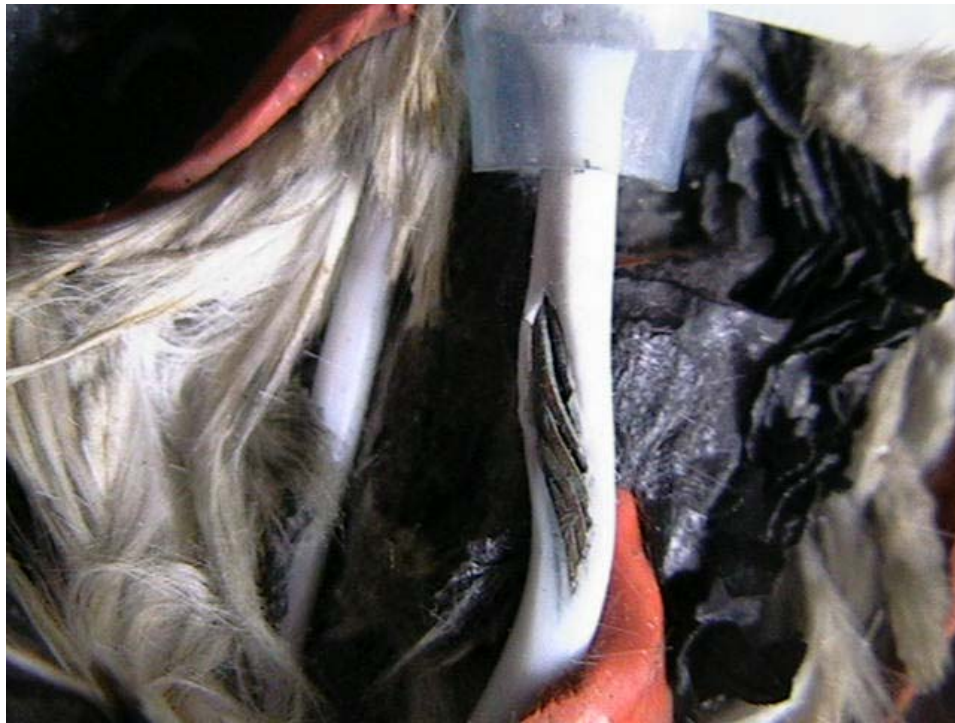
Figure 49. Exposed Inner Conductor in the Cessna 402C Right Engine Compartment

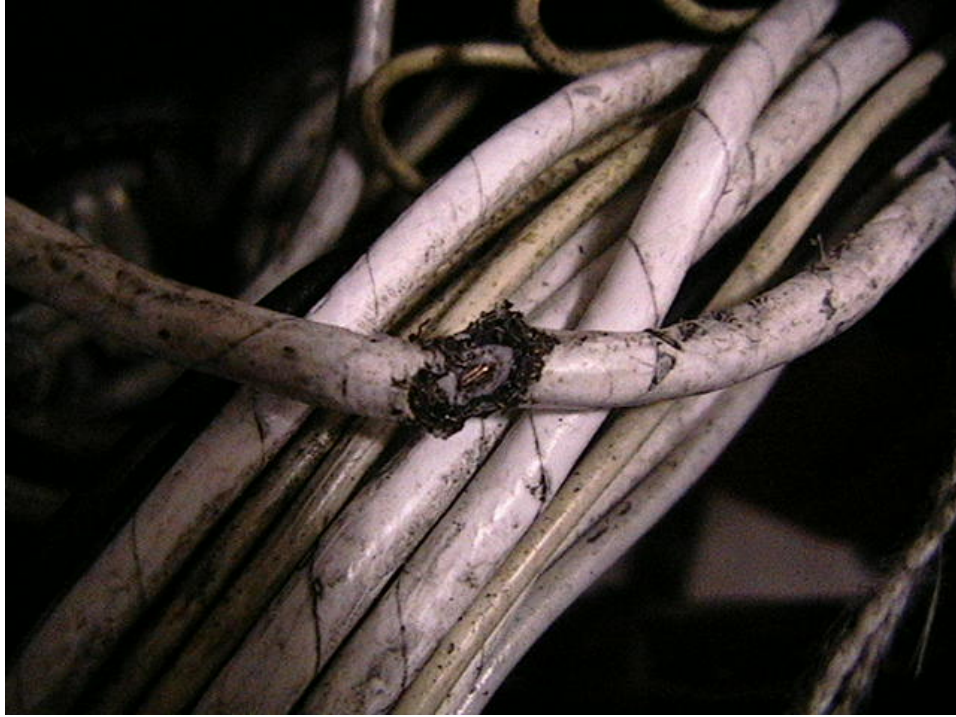
Figure 50. Damaged Shield Due to Cut Insulation in the Cessna 402C Right Engine Compartment

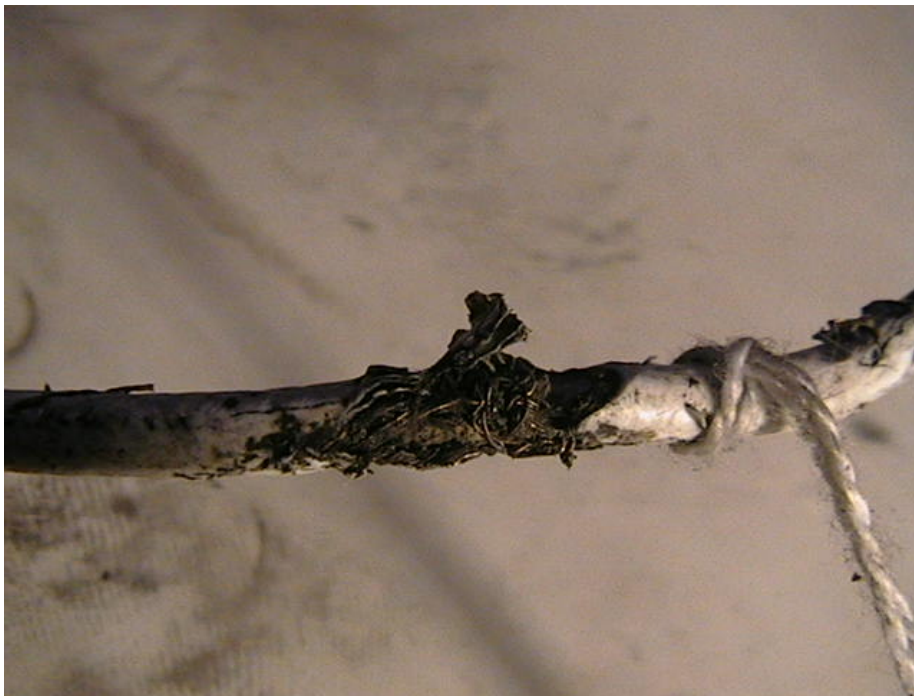
Figure 51. Damaged Outer Shield in the Cessna 402C Left Engine Compartment

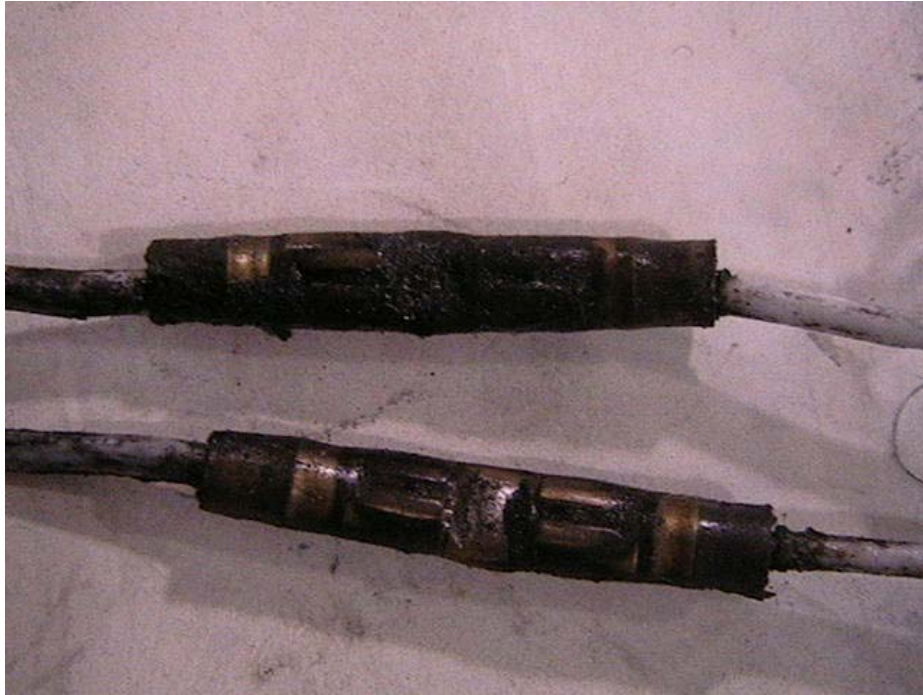
Figure 52. Grease Contamination at the Splices in the Cessna 402C Left Engine Compartment

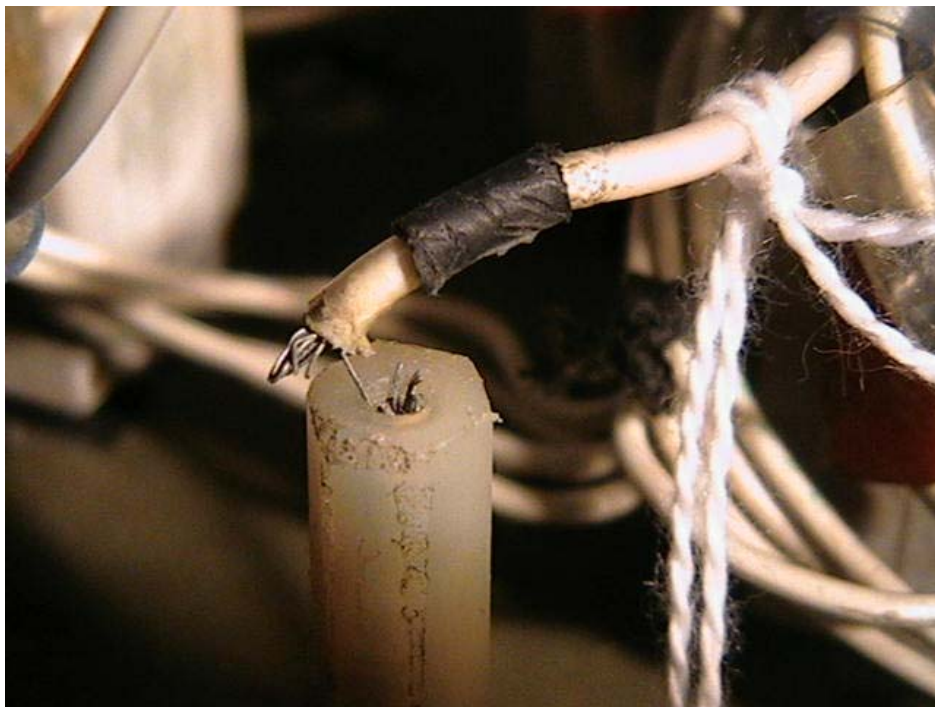
Figure 53. Broken Connection in the Right Console of the Cessna 402C

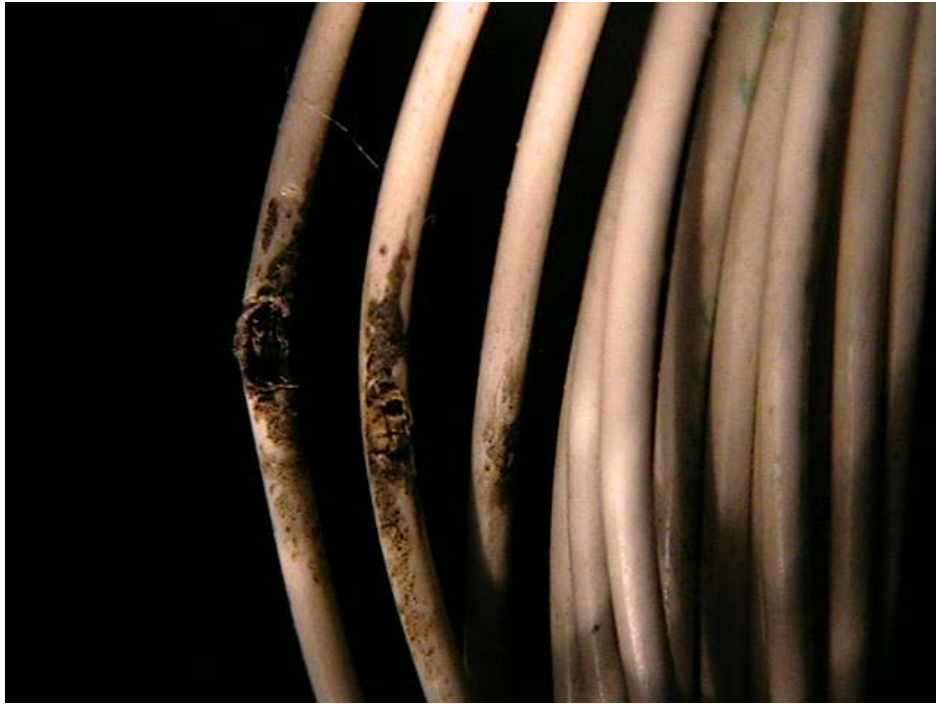
Figure 54. Heat-Damaged Inner Conductor in the Cessna 402C Right Console

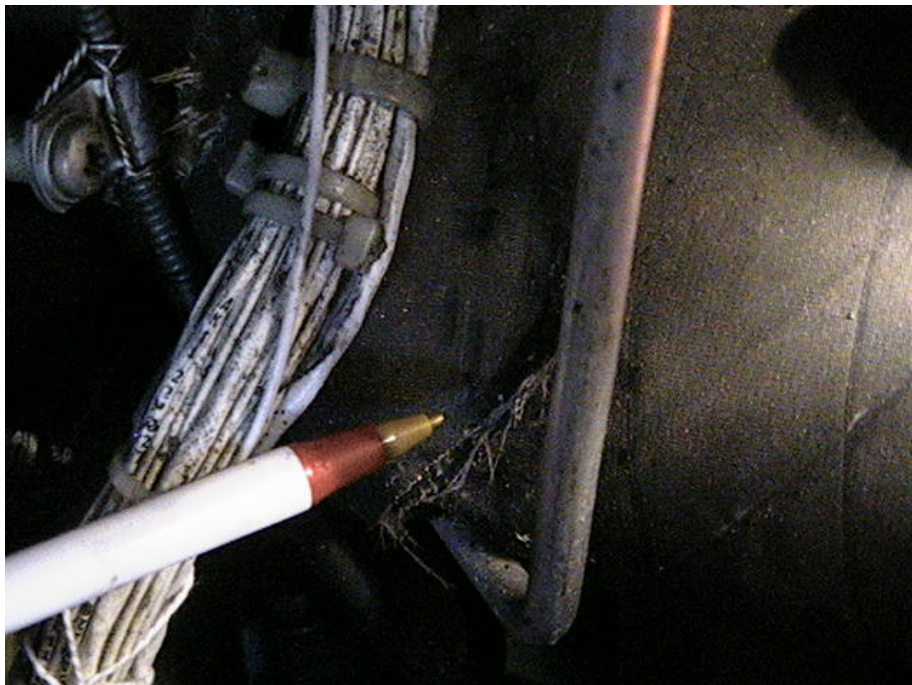
Figure 55. Damaged Air Inlet Pipe Due to Inadequate Clearance of the Wire Bundle in the Cessna 402C Forward Bulkhead Region

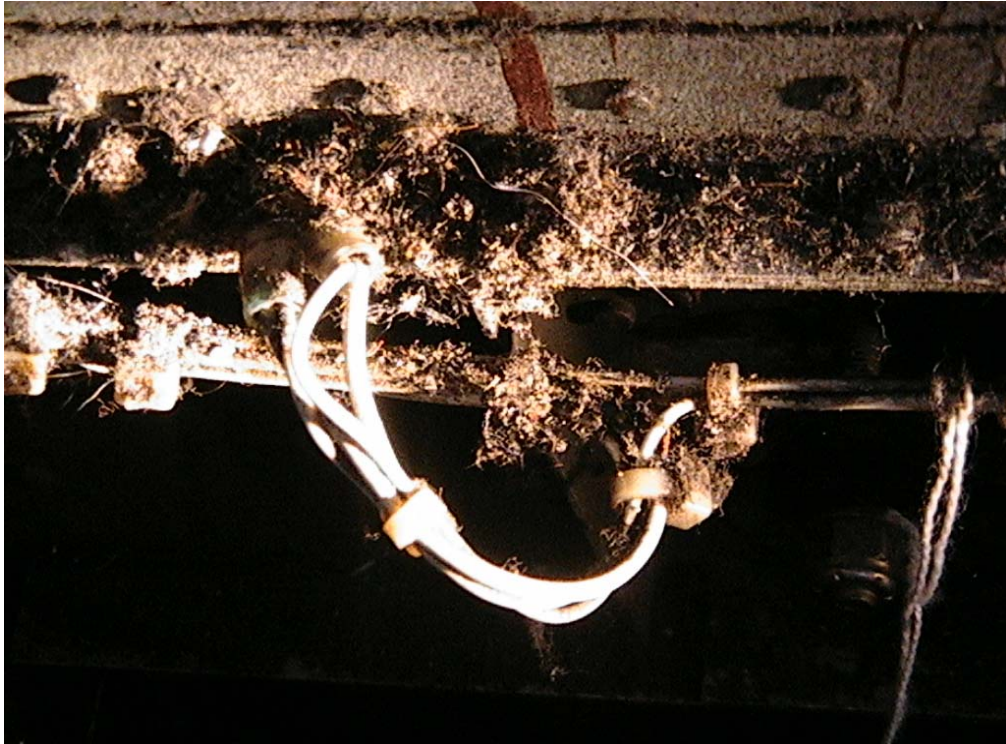
Figure 56. Dust Contamination of Wire Bundle in the Cessna 402C Baggage Compartment

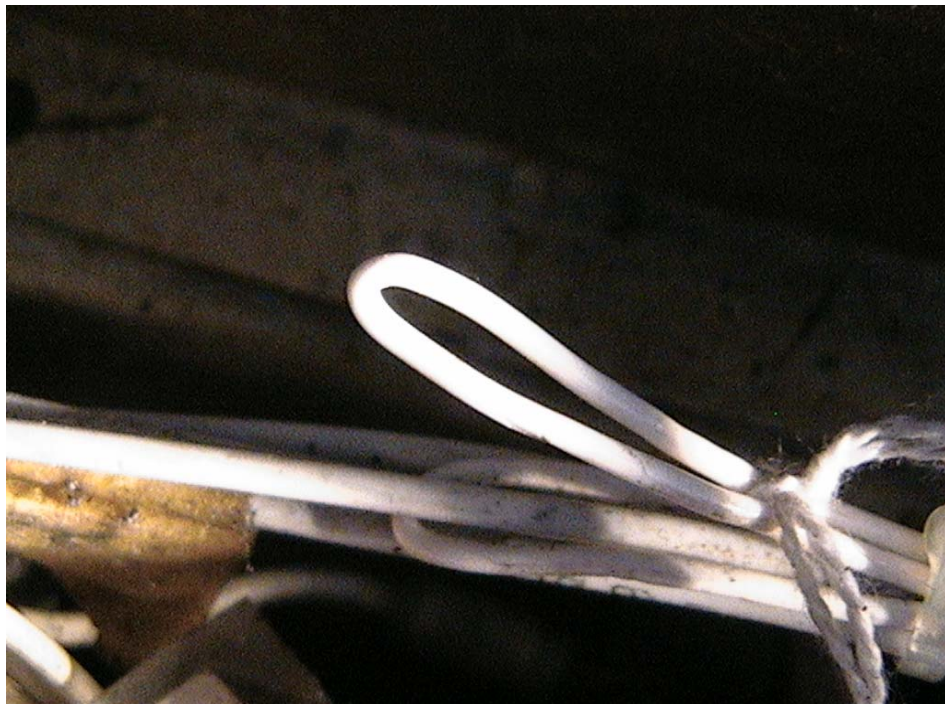
Figure 57. Improper Bend Radii Observed in the Cessna 402C Baggage Compartment

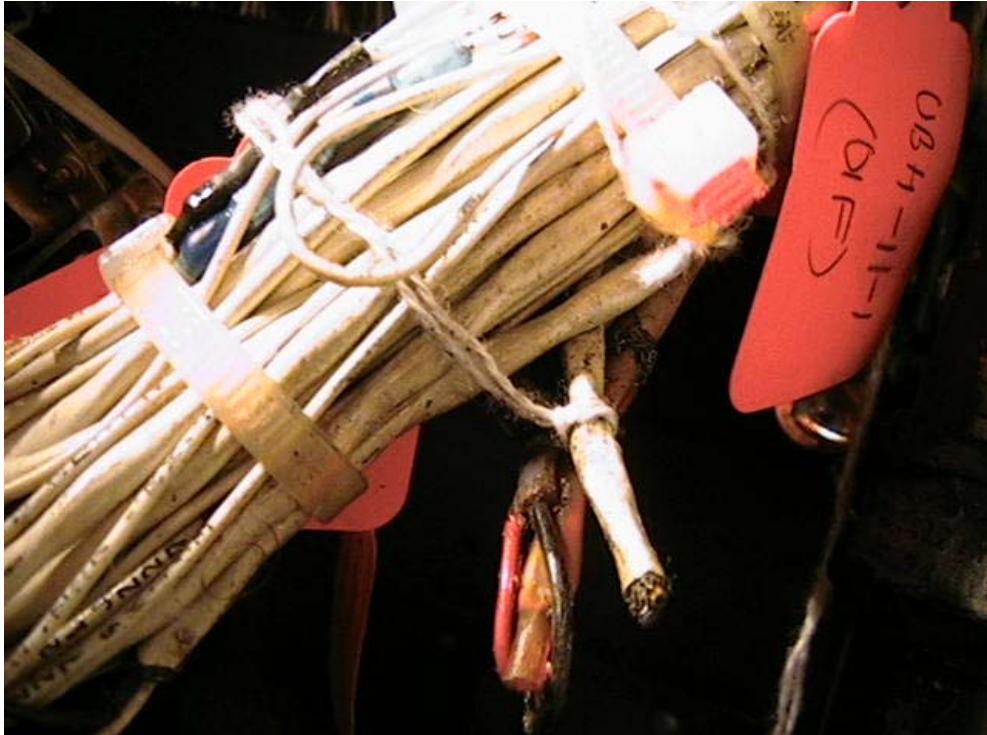
Figure 58. Unused Wires Improperly Stowed in the Cessna 402C Upper Bulkhead Region

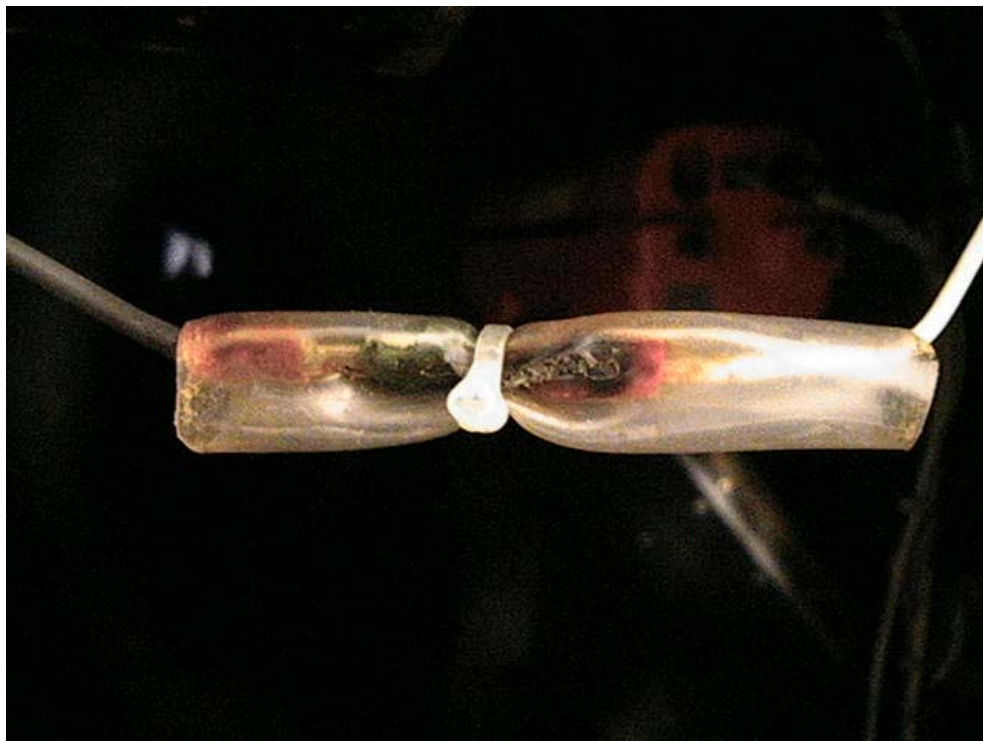
Figure 59. Heat-Damaged Wire in the Cessna 402C Tail Section

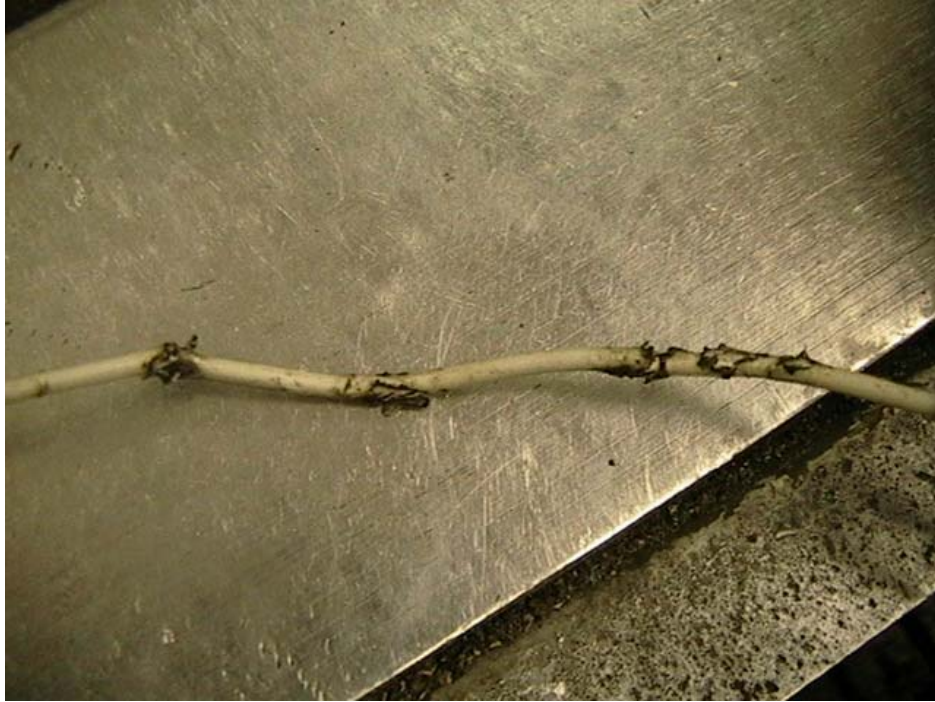
Figure 60. Cracked Insulation in the Cessna 402C Cockpit Floor

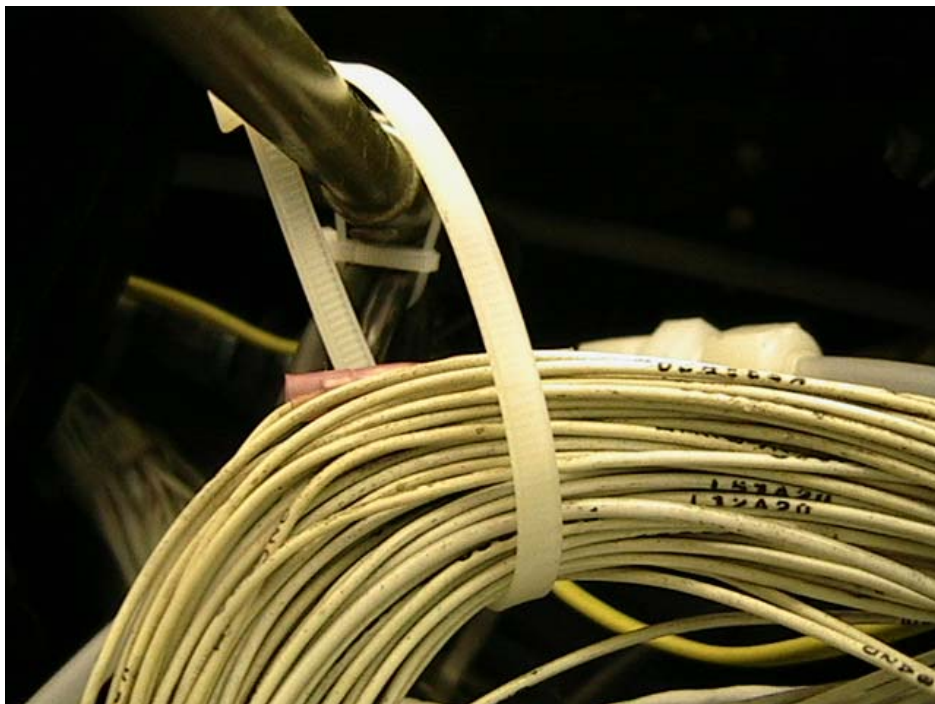
Figure 61. Improper Clamp Size in the Cessna 402C Instrument Panel
