DOT/FAA/AR-07/35

Summary and Comparison Report on Teardown Evaluation of Cessna 402A and Cessna 402C Airplanes

June 2007

Final Report

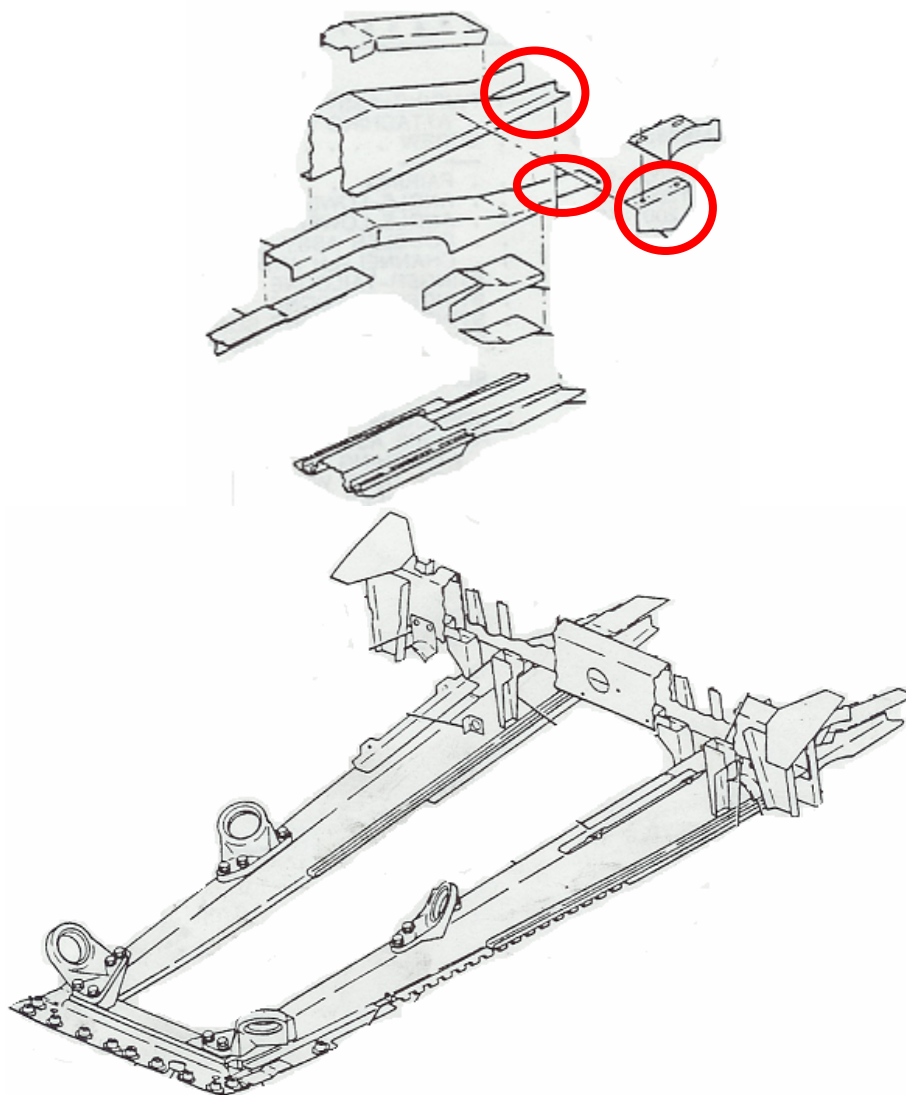
Figure 24. Illustrated Parts Breakout of the Cessna 402C Engine Beam Structure

During the detailed disassembly, cracks were found on the engine structure. Table 1 lists structural details found cracked in the engine structure as well as the crack orientation relative to the wing front spar. As illustrated in figure 24, cracks were located on the inboard and outboard engine beams where they attach to the lower front wing spar. Specifically, cracks were located on the inboard engine beam of the right wing, on an angle assembly on the right outboard engine beam and on the channels of the left and right outboard engine beams along with the channel of the right inboard engine beam.

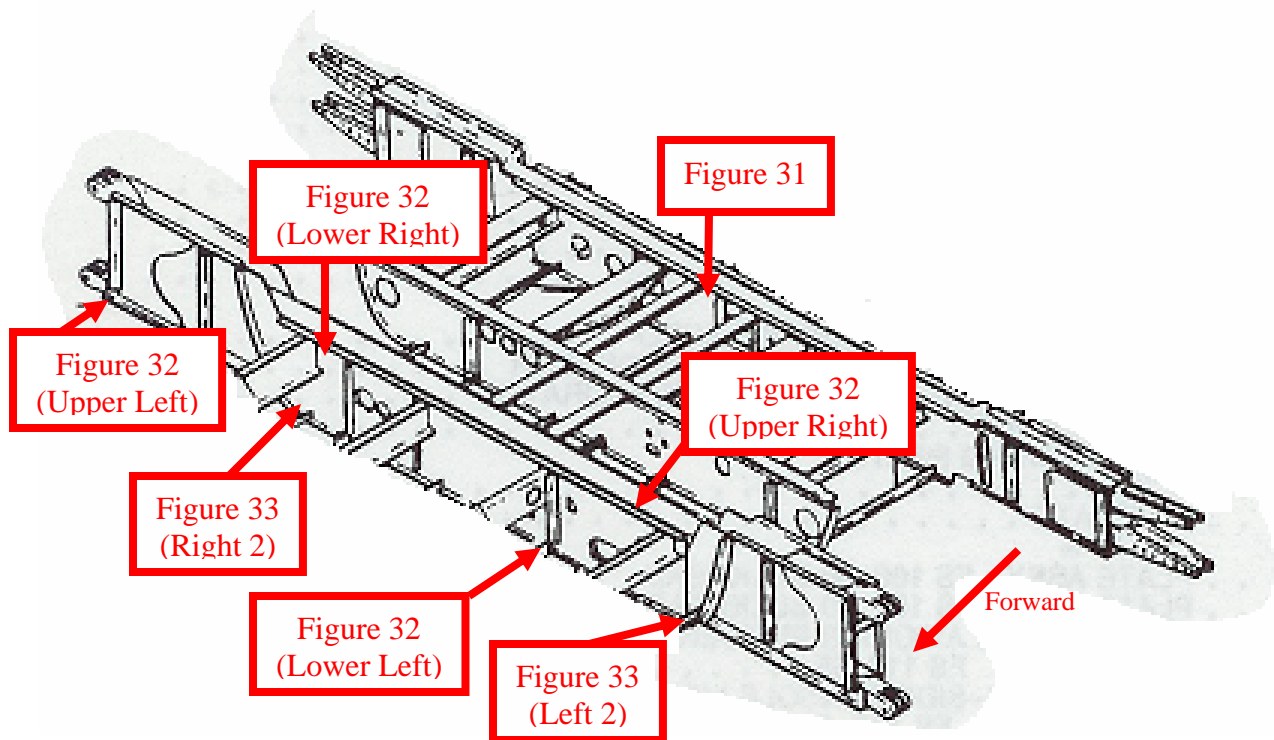
Figure 30. Wing Carry-Through Structure

Cracks were also discovered on the fuselage carry-through structure during removal. Table 2 documents the location and number of cracks found in the carry-through structure. Forty-three total cracks were discovered, ranging in length from 0.13 to 2.98 inches. Figure 30 shows the carry-through structure. Figure 31 shows a crack found in the aft carry-through forward web, part number 5211173-4. This particular crack was found on the left-hand side at BL 1. The forward carry-through forward web, part number 5211172-5, was found to have 17 cracks. Four of these cracks are shown in figure 32. Figure 33 shows four of the cracks found in the forward carry-through aft web. The mode of failure for these cracks was determined to be fatigue during the microscopic examination.
